EVALUATION OF EXISTING CONDITIONS

SUMMARY EVALUATION OF EXISTING CONDITIONS

EXISTING CONDITIONS | BUILDING CONDITIONS

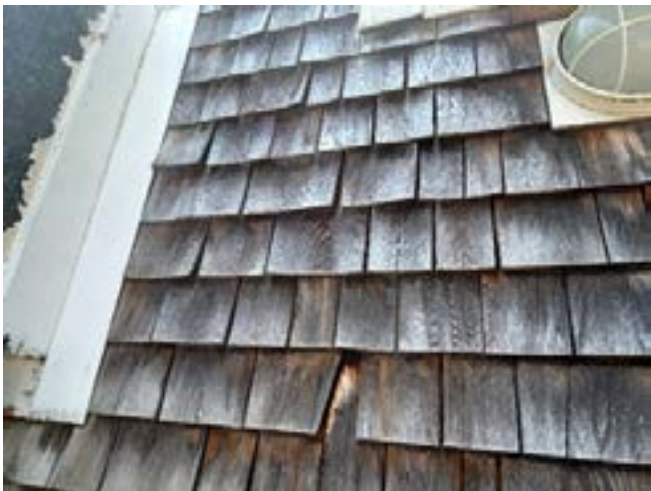
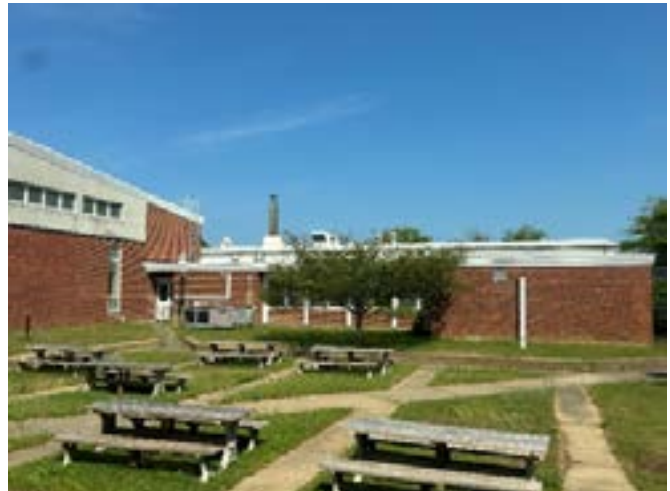
The original exterior façade is red brick with wood-frame windows. The masonry is deteriorating, and mortar joints have cracks. Large amounts of masonry sealant have failed. The siding on the 1979 and 1995 additions is cedar shingles with wood trim and aluminum windows. The cedar shingles have weather-related damage, curling, breaking, and disintegrating. Many are missing. The school has begun to replace small portions of the exterior shingles with new cedar shingles and in some locations have replaced the cedar shingles with cement board mimicking shingles.

According to the 1959 drawings, no insulation is called for. In the subsequent additions, insulation was provided but does not meet today's standards. Currently unit ventilators are at multiple locations along exterior walls. Removal of these units will trigger insulating requirements for those portions of the wall becoming exposed / accessible. Code wise, these areas would need to be insulated. In practical terms it may be difficult to be selective and avoid opening walls to install new building systems. Therefore, it is recommended to take it one step further and insulate the remaining portions. This approach would provide more resilience in the building envelope, and help the project meet its sustainability goals.

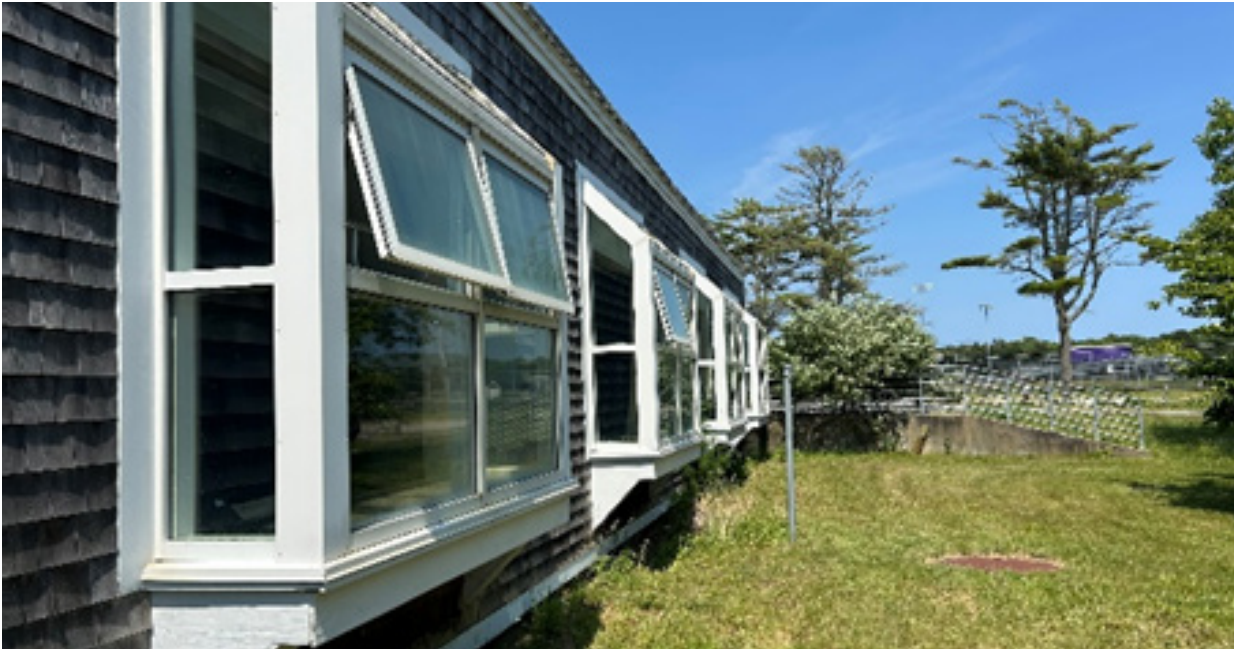
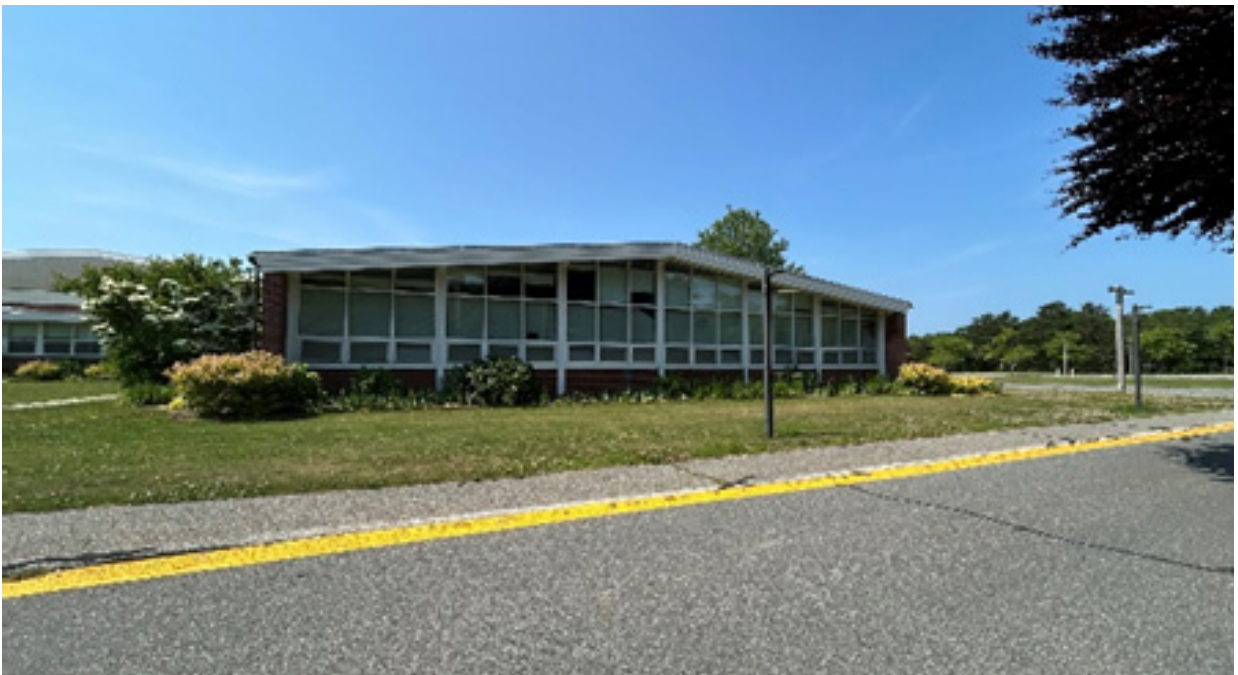
Openings

Exterior windows are mostly aluminum framed, with some vinyl and wood frames windows. Exterior doors are metal with mostly metal frames. Dozens of windows are fogged from failed glazing, and hardware is broken or missing. Window screens and brackets are torn or non-existent. It is also reported that the attempts to fix the skylights in the gym from leaking have not been sufficient. Leaks from those skylights and others in the building have been reported. It is also reported that many windows leak during heavy rains, causing damage to the interior.

To meet current energy code standards, any new or replaced fenestration in the existing building must be a High-Performance triple glazing insulated glass system. See additional recommendation in the Conclusions section below. Rotted wood window frames in the 1995 addition have also allowed water to infiltrate the interior, allowing mold to grow.

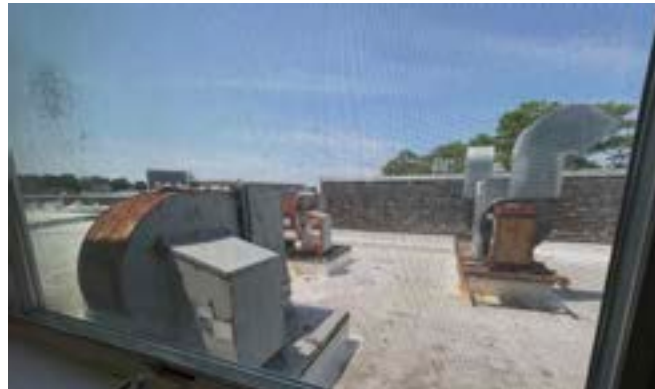
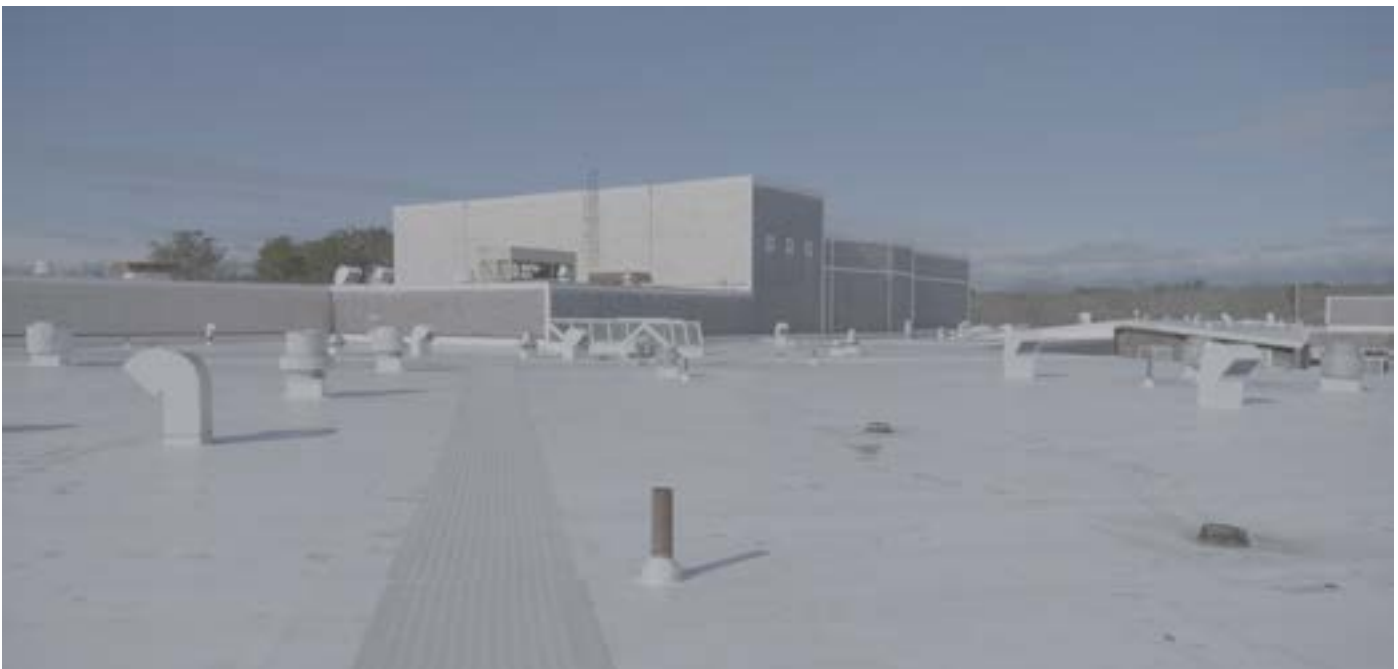
Roof

The building has predominantly flat roofs with some slightly pitched areas. As a result of roof leaks approximately 85% of the roof was replaced in 2013 with PVC that comes with a 20-year warranty. The remaining roof that was not replaced is either EPDM that is approaching the end of its useful life span, or there is a small amount of copper roofing on certain features of the 1995 addition. Gutters with downspouts exist around most of the entire building and are either copper or aluminum. Consequential problems exist in all areas of the building envelope. Water damage to ceiling tiles and wallboard have resulted.

Any roof alterations (beyond basic repairs) as a result of renovation or new work must comply with the current Energy Code. (2021 IECC with Stretch Code amendments). Therefore, it is recommended to do a full replacement with Code compliant insulation thickness. This approach not only improves thermal performance overall, but also gives a single starting point for the entire roof as far as expected longevity and warranties.

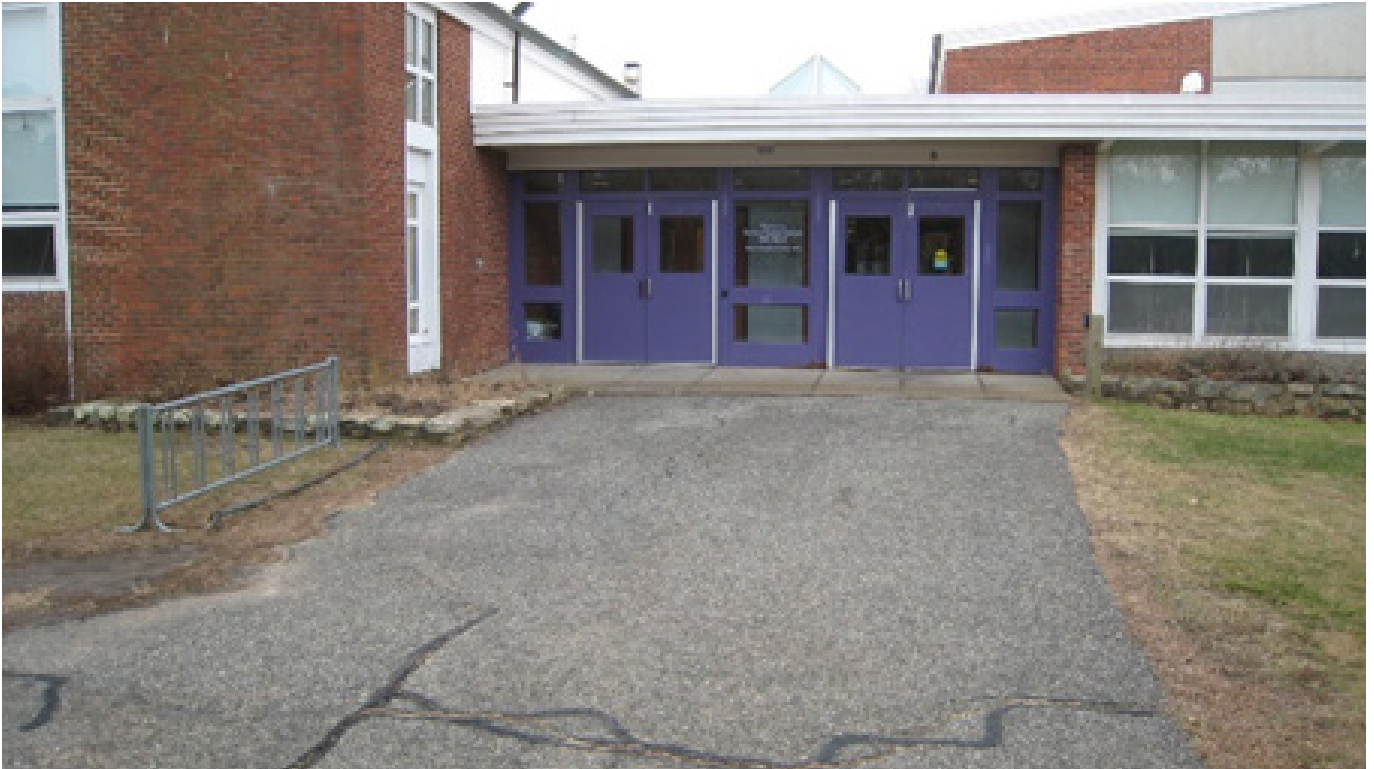
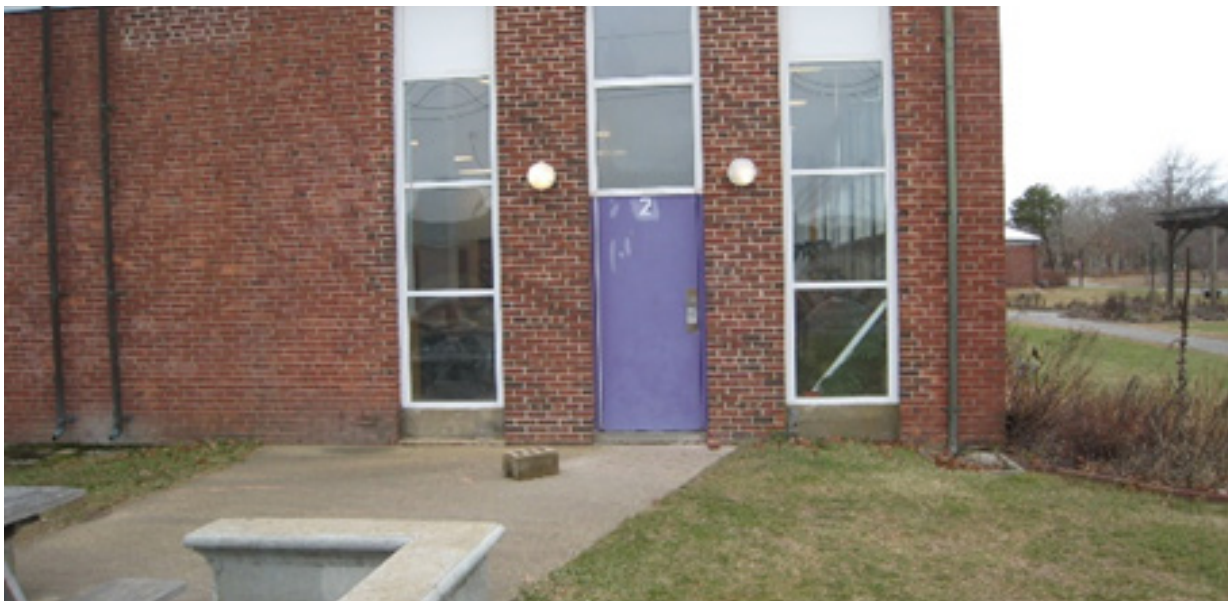
Building Entrances

The main entrance is covered by a canopy. Some of the other side entrances have canopies while others do not. Some entrances including the main entrance are ADA noncompliant because their slope exceeds the maximum 2% limit. The majority of the exterior doors are noncompliant. Any renovation will have to address this.

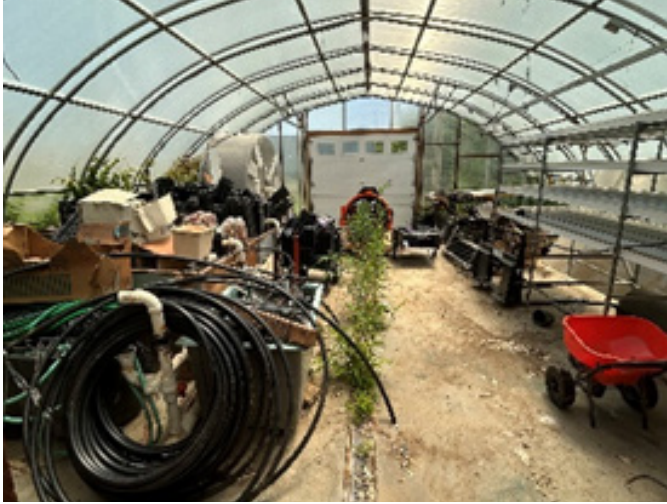
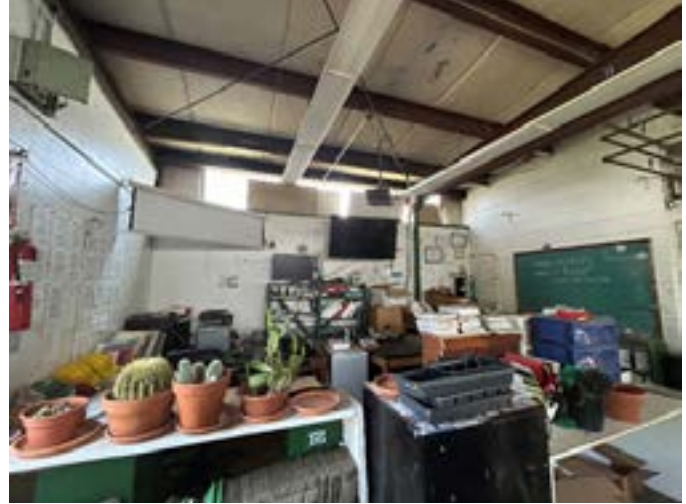
The Horticulture facility has significant deficiencies, including crumbling foundations, inoperable/unsecured doors and windows, hazed over transparency panels and inoperable venting, and inadequate HVAC and ADA accessibility. The facility does not have bathrooms.

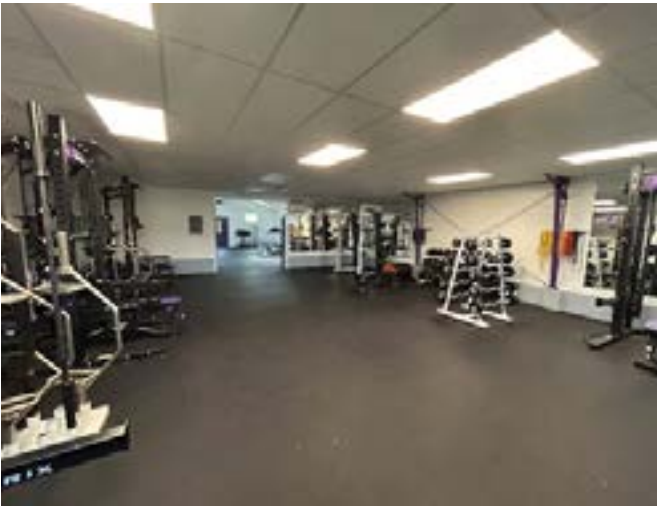
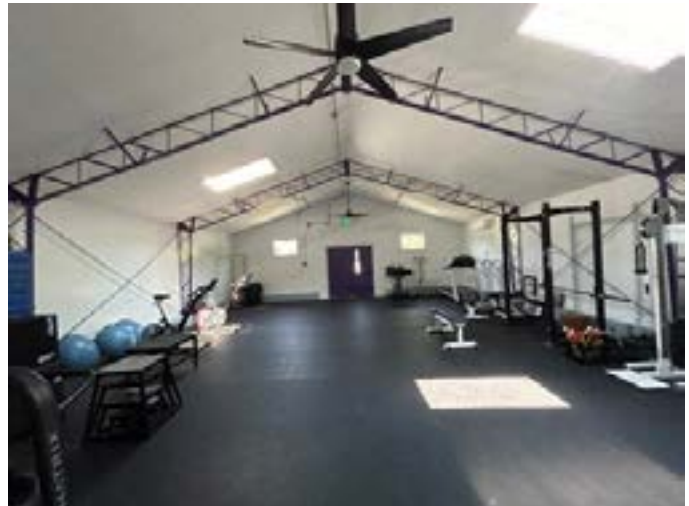
The weight room is separate from the main building and has inadequate HVAC and ADA accessibility. The ACT ceiling and rubber flooring appear to be in decent condition. Having the small weight room away from the school is not conducive for PE class use or helpful for the athletic program.

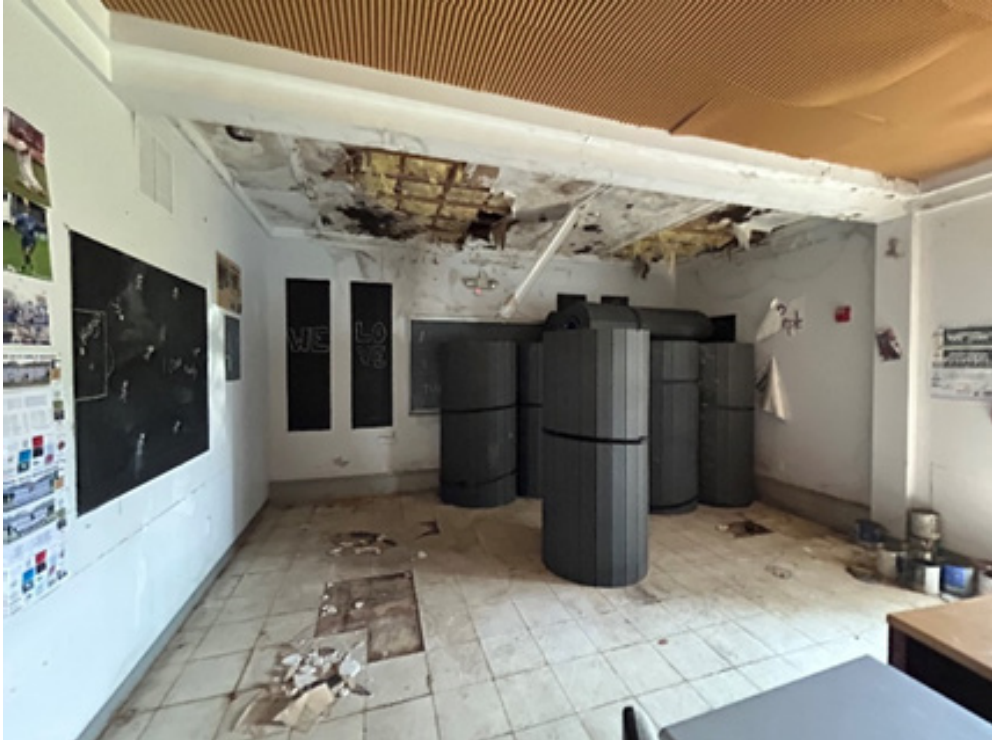
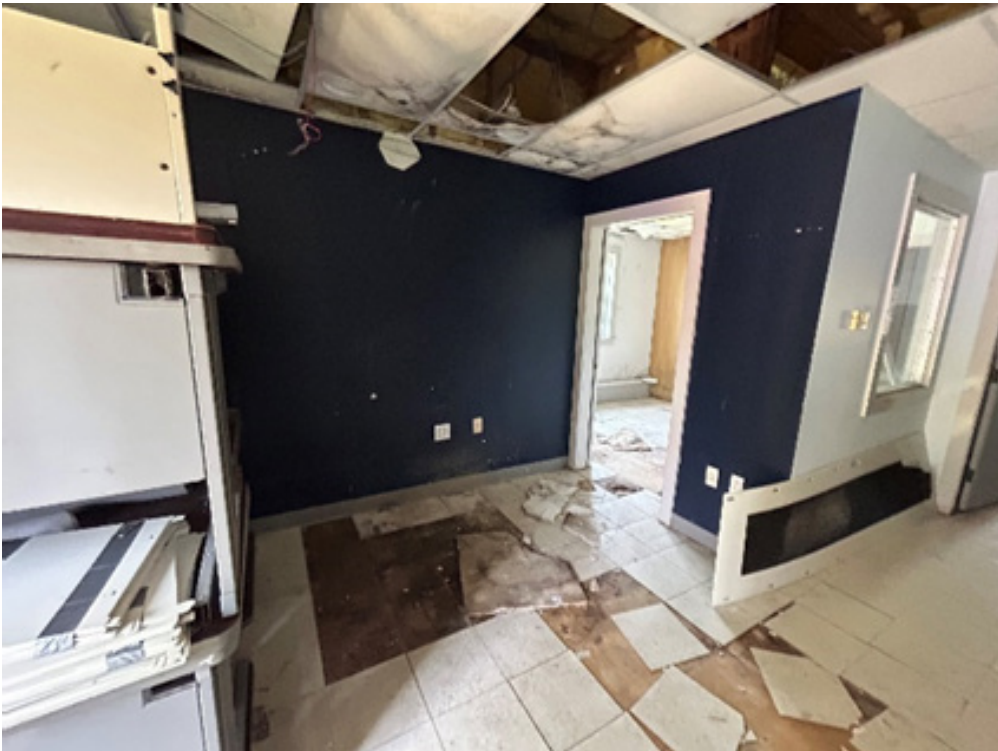
There is an abandoned free-standing classroom building that is in total disrepair. The ceilings have been severely damaged by water and have fallen in some parts. The flooring appears to be VCT and there are tiles missing. Mold is visible in multiple areas on the ceiling and walls of the building. It appears that this building is used for storage. Athletic mats were seen stored in the building.

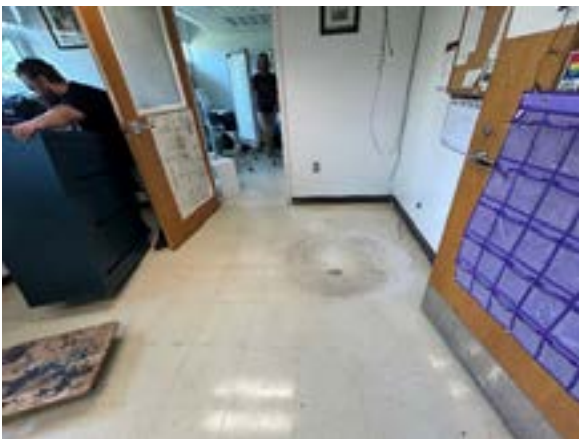
Flooring is predominately VCT in all classrooms and public spaces. There is carpet in the administration areas and in the library, there is a mix of carpet and LVT. Some of the flooring has been replaced as asbestos abatement has been happening periodically. The flooring in the main kitchen and CTE spaces is concrete. The flooring in the Culinary Arts kitchen is tile. The ramps connecting the different additions have rubber flooring. The flooring throughout the building is worn.

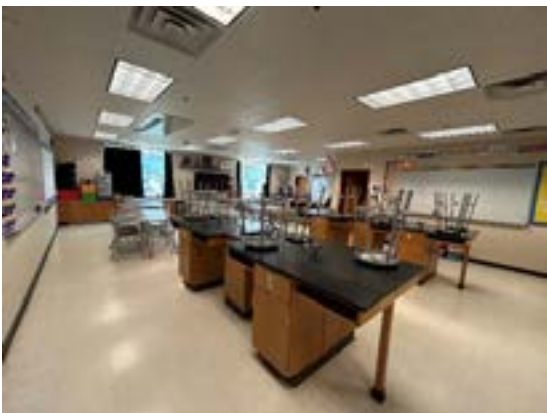
The casework throughout the building (especially in the science labs) should be replaced. The science labs have reported unsafe storage conditions and other areas are showing signs of general wear and tear. Fixed lab stations in the middle of the classroom reduces flexibility and can create congestion. Renovation considerations must include casework upgrades to meet MAAB requirements. In addition to the replacement of casework, any future project should consider the actual utility of the metal lockers located throughout the building. To replace the lockers with a more appropriate size unit would be costly and it is reported that the sprawling nature of the high school the lockers are not used particularly well and are hard to get to in the short amount of time between classes. Removing lockers could allow for space saving design changes and more space in classrooms or directed toward 21st century learning initiatives.

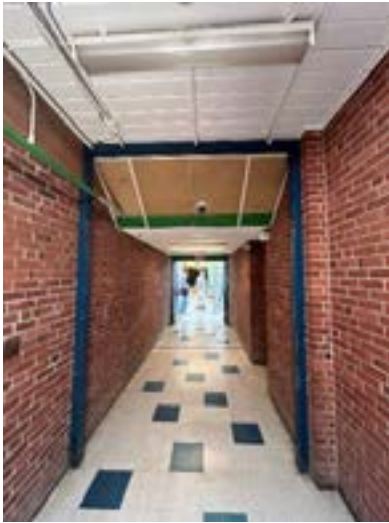
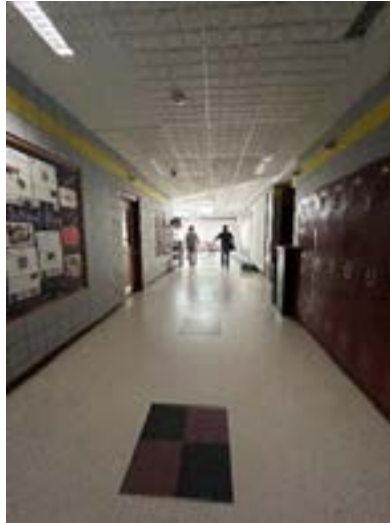
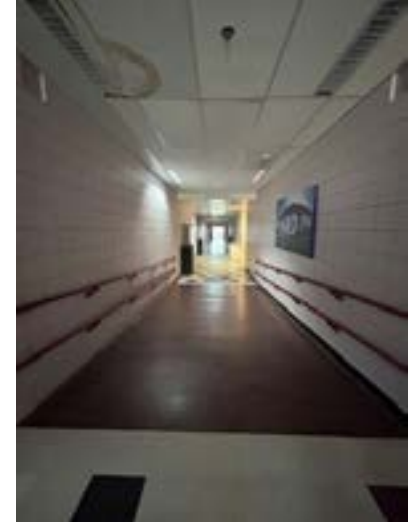
The nature of a one-story figure eight shaped school means that there is a lot of corridor space. The travel distance and time around the school is significant. The corridors are narrow and provide no space for 21st century learning initiatives. The corridor walls in the original portion of the building are brick. In the later additions the corridor walls are painted CMU, concrete block and painted plaster. The brick adds a nice character to the corridors, but the corridors are generally dark apart from the areas where two corridors meet, and overhead skylights provide daylighting. The ACT ceiling in parts have water stains. The corridors lack property HVAC systems which can make them very cold in the winter. There are a lot of exposed pipes throughout the corridors.

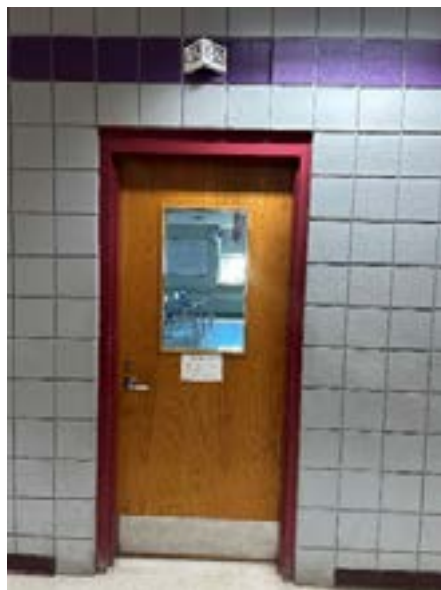
Generally, the toilet rooms have painted CMU walls and epoxy floors. There are portions of the epoxy flooring in some toilet rooms that appear to be deteriorating with chips and holes around the perimeter of the room. Fixtures appear to be in decent condition but may not meet code requirements for accessibility or flow rates. However, due to the most recent (and more stringent) version of the plumbing code, additional code compliant plumbing fixtures including toilets, lavatories, urinals and drinking fountains will be required. Most of the toilet rooms appear to have epoxy flooring. There are portions of the epoxy that appear to be deteriorating.

Currently room signs are mounted above the doors, which is not in compliance with MAAB. Signage needs replacement to meet MAAB requirements and to address proposed room numbering.

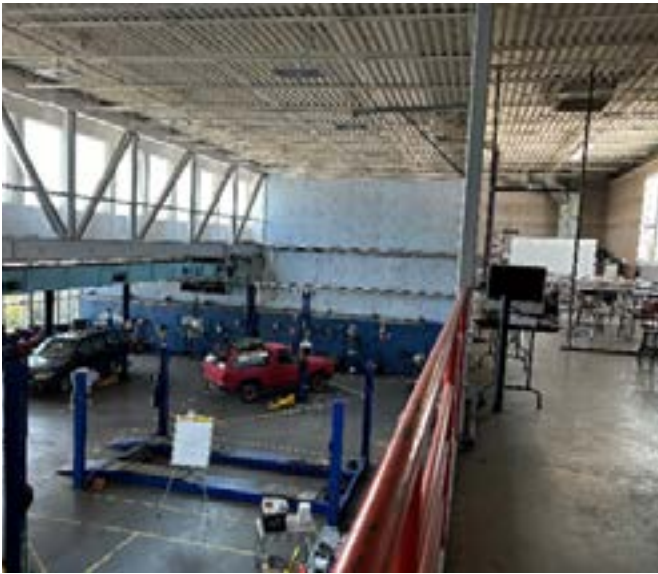
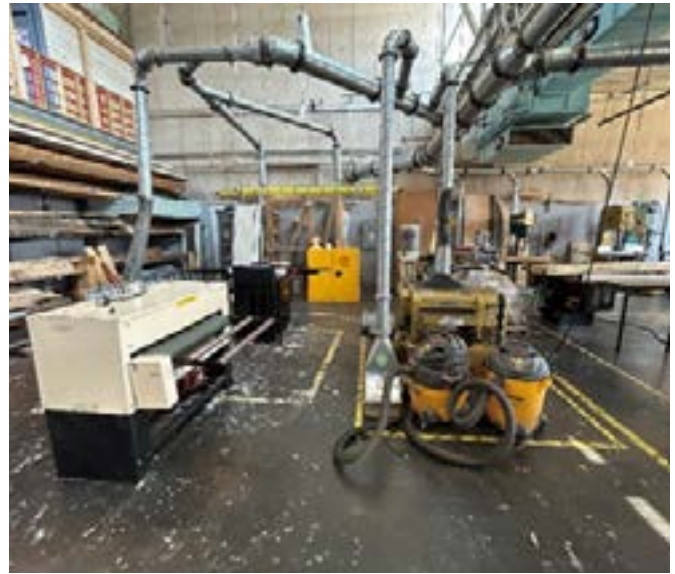
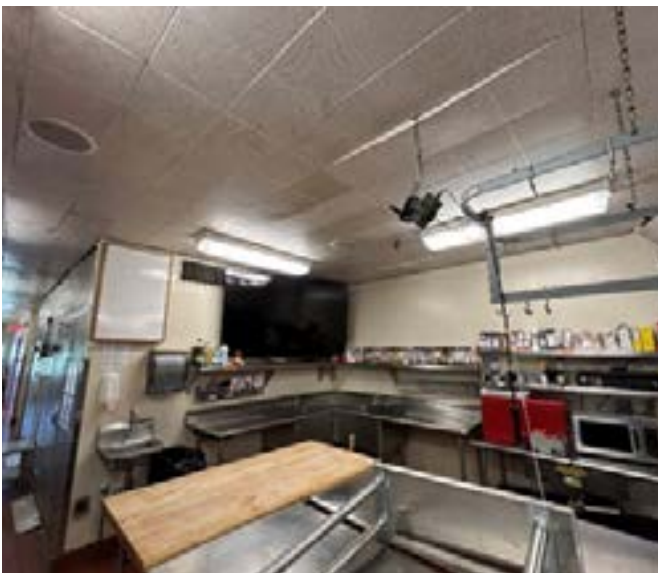
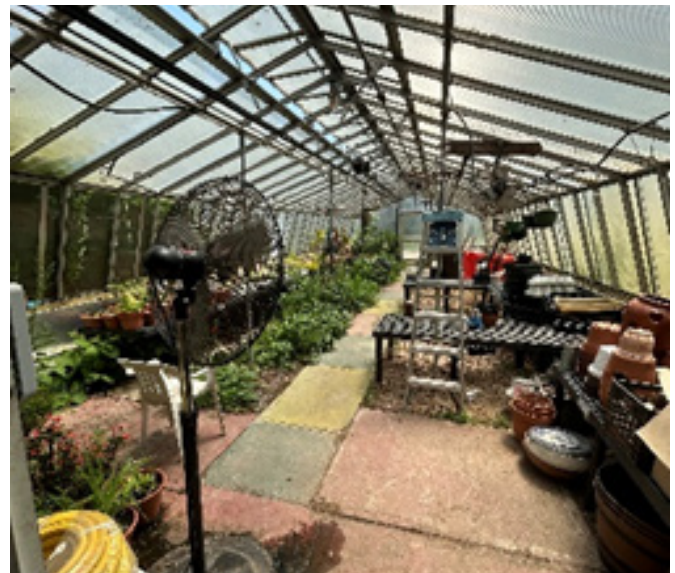
All the CTE program spaces are too small compared to the state standards. The automotive and carpentry programs have the most space out of all the programs. However, they do not have any instructional space that is accessible. There is lofted space above that doubles as storage and instructional space. The automotive and carpentry spaces have had the most extensive remodel to date due the failings of the exterior wall. The finishes are worn in the culinary arts teaching kitchen and better instructional and preparation space is needed. The health assist and early education programs are currently located in general classrooms which do not meet the needs of the programs. The marine technology program does not have a dedicated space and bounces from space to space depending on the year. The horticultural program's greenhouse and facilities do not meet the needs of the program and are deficient.

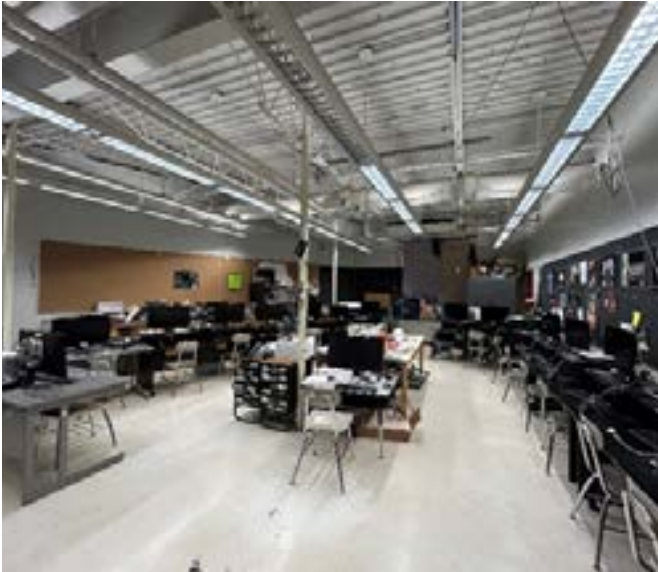
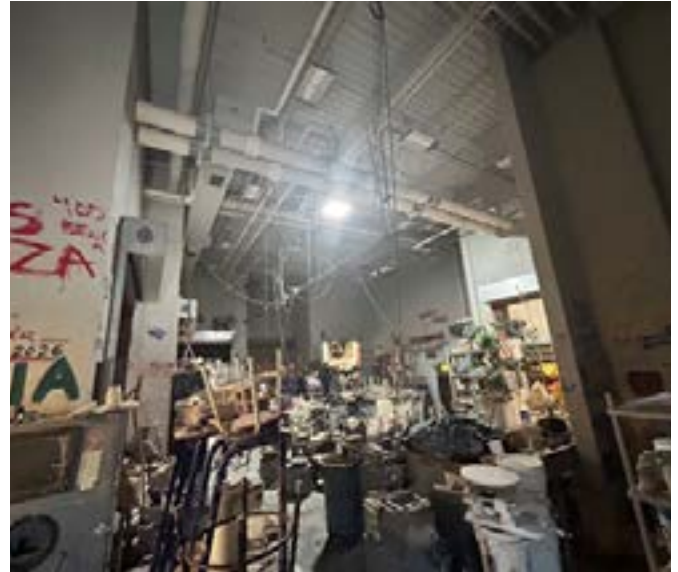
The ceramics art room was the prop and set building room in the original plans. It has tall ceilings and CMU walls with concrete floors. It has many little storage nooks while being dirty and cluttered with limited accessibility for any disabled persons. One of the art classrooms doesn't have windows or proper ventilation for the equipment used in that space. All of the casework and storage in the art rooms will need to be replaced and brought up to MAAB standards.

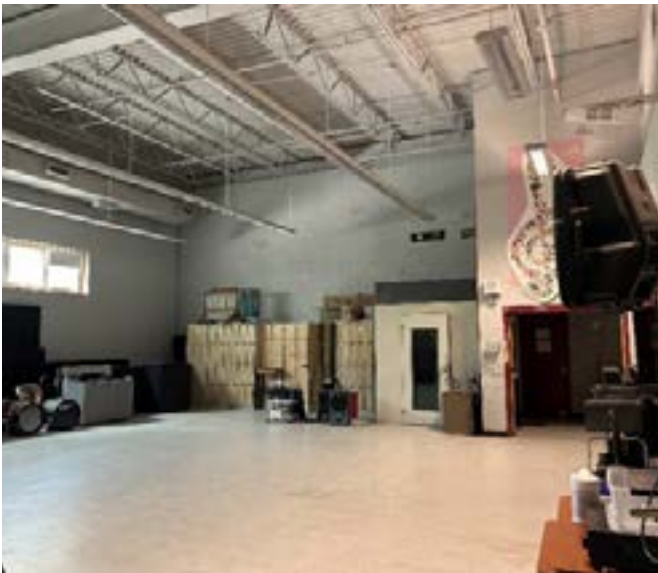
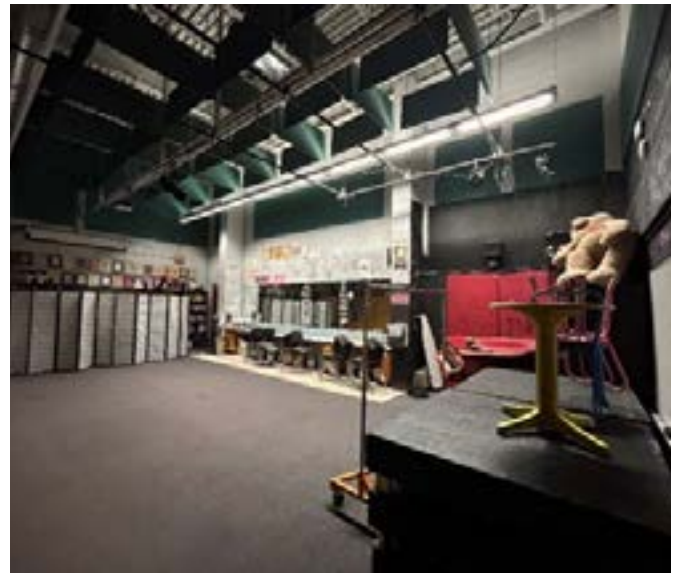
The music classrooms are tall spaces with CMU walls with exposed roof structure and systems. They are lacking acoustical treatment. The VCT flooring is worn. The department has insufficient space for all of their programs.

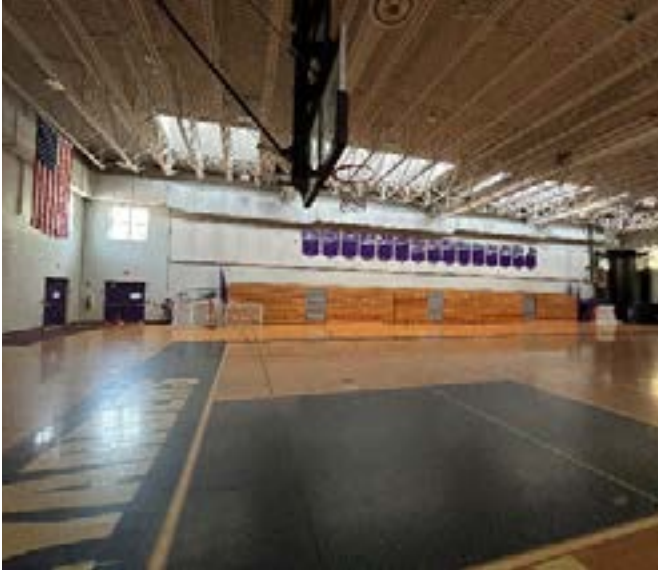
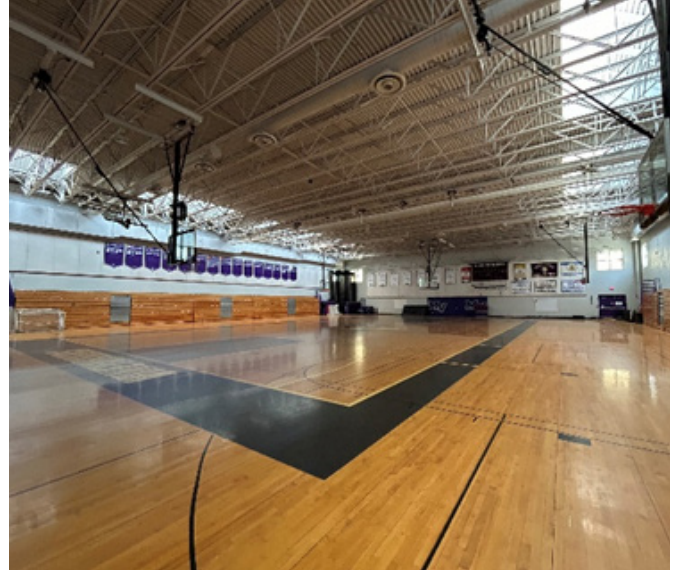
The gym walls are painted CMU. The roof is supported by structural bar joists. Bleachers appear to be original and appear to be in good shape. However, the bleachers do not have cutouts for HC wheelchair space and companion seating. Gym equipment appears functional but is reaching its life expectancy. Renovation considerations shall include full replacement with HC compliant bleachers and should include replacement of gym equipment (backboards, scoreboard and curtain). It has been noted that the skylights leak.

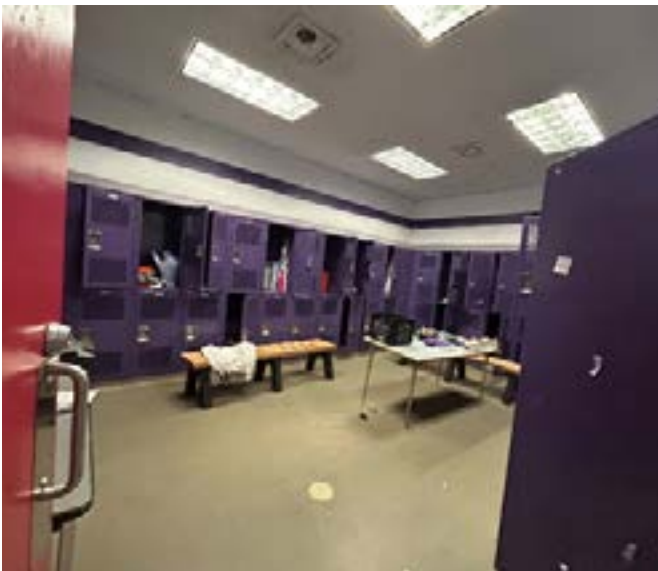
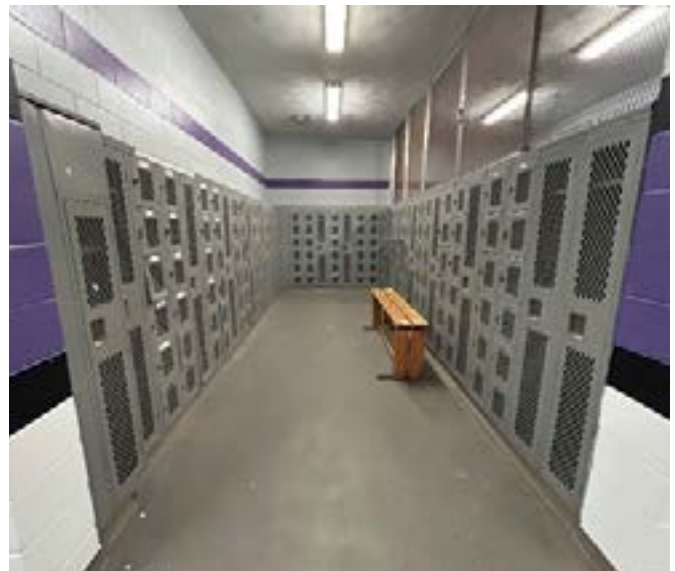
The locker rooms/ showers are worn but in relatively decent condition. The walls are painted CMU and the ceiling is painted drywall. Any renovations would have to make sure the restroom and showers in the locker rooms comply with the latest code and ADA requirements. Currently, the showers are used for storage. Renovation considerations should include full reorganization and renovation of these spaces.

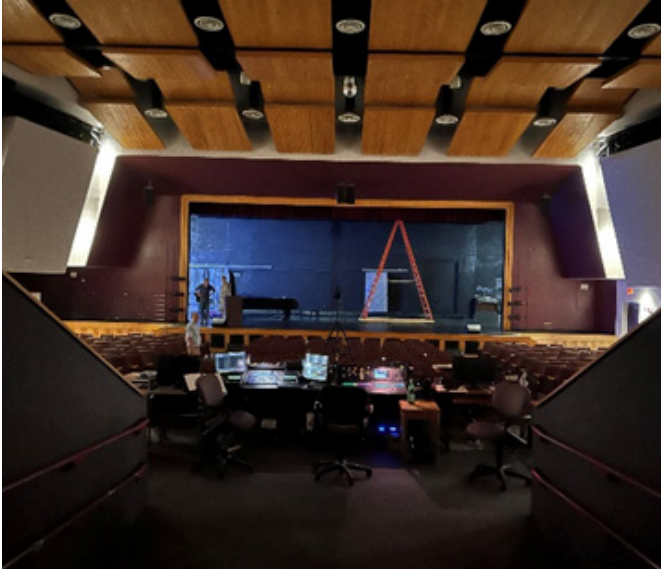
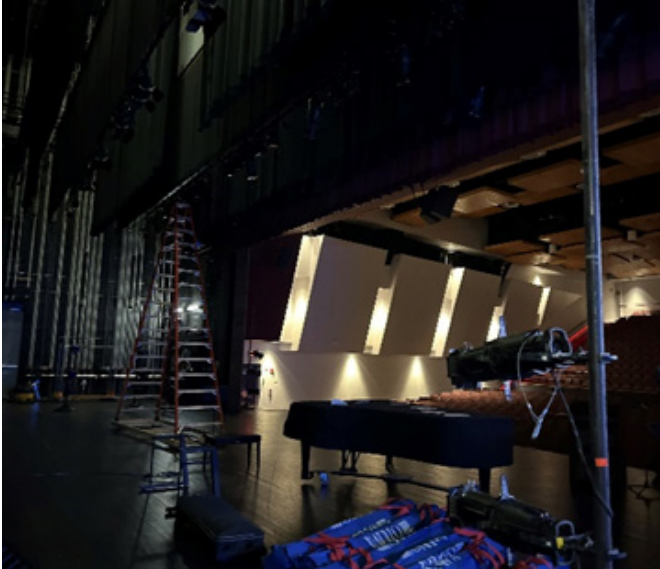
The Auditorium (PAC) is in good condition. Seating capacity is just under 800 seats. Access to the stage is via a ramp and side doors from the corridor. There is no dedicated control room for audio and lighting. All new MEP systems will be needed. At a minimum, cosmetic finish upgrades would be necessary in any renovation considerations. Further evaluation of ceiling acoustic baffles and wall acoustic baffles will be needed.

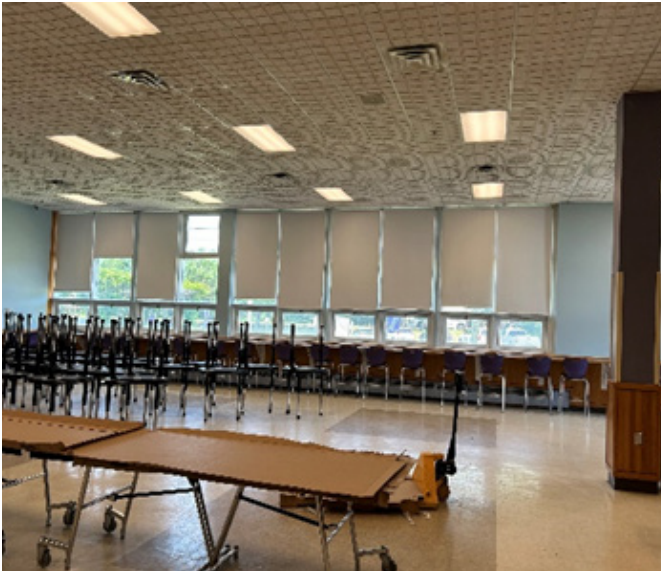
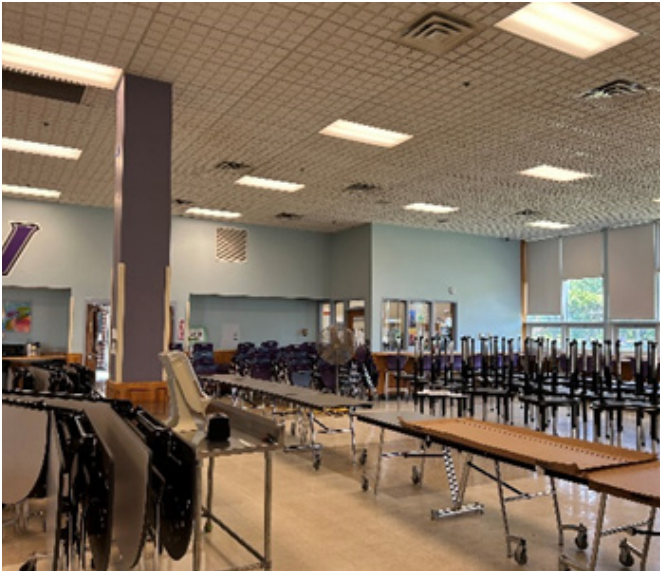
The cafeteria is too small for the current student capacity. Some ceiling tiles have water stains and are wavy. The VCT flooring is cracked in some locations. The painted walls need to be repainted.

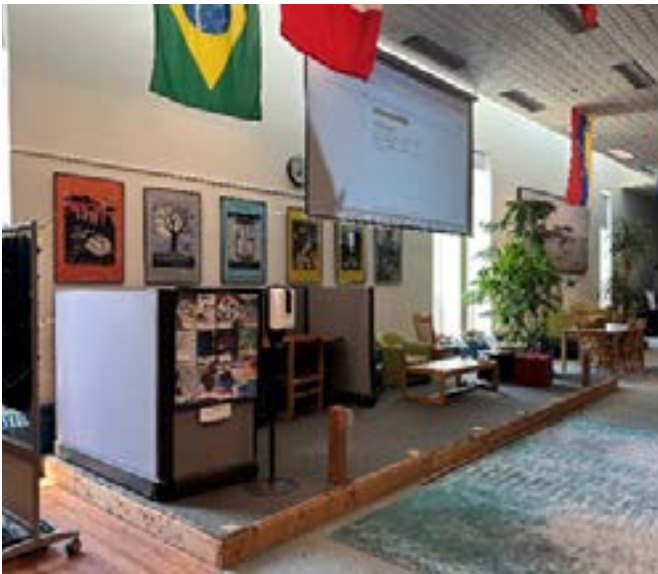
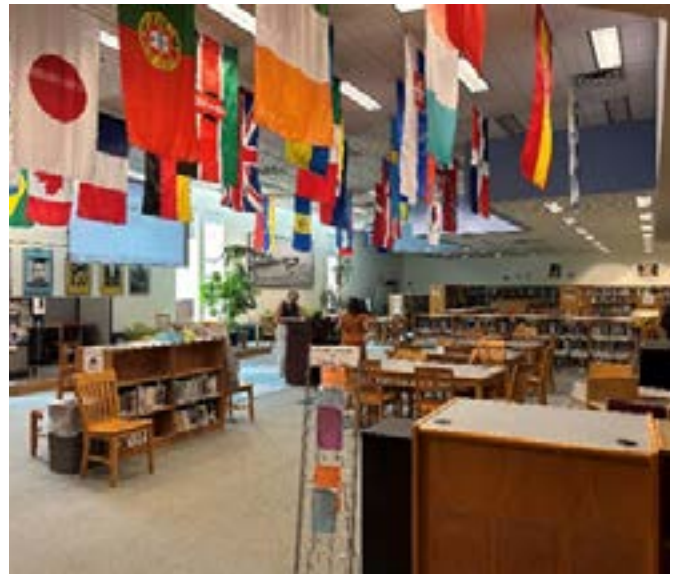
The Media center is well maintained and is one of the only spaces in the school that is air-conditioned. However, layout modifications (say, stacks or circ desk) and / or new building systems installation will require replacement of carpet and ACT. There is a raised platform that is not accessible. Any renovation will need to address it and make the entire space completely accessible.

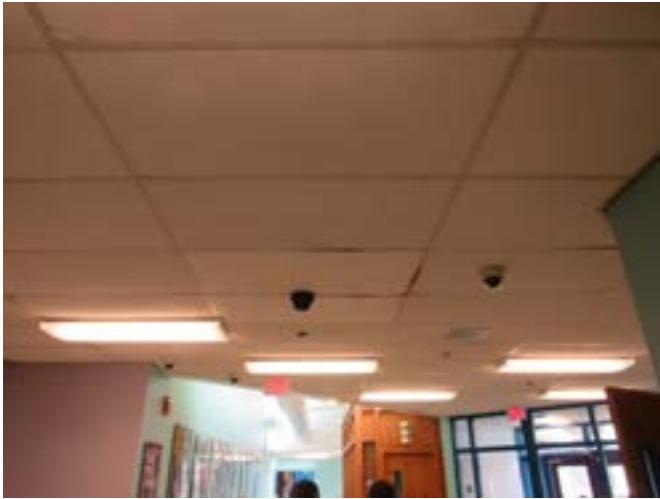
POOR CONDITION OF DROP CEILING AND MULTIPLE CAMERAS AT APEX.

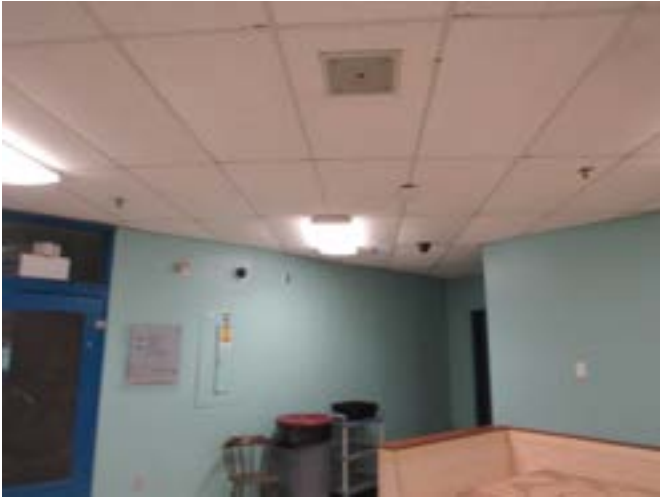
DIFFERENT CAMERA MANUFACTURERS AND MOUNTING METHODOLOGIES. NO CONSISTENCY.

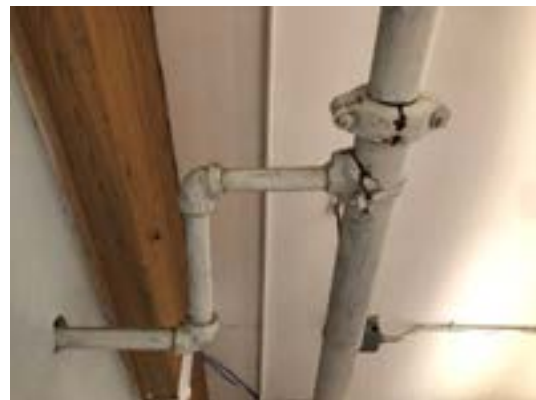
Sprinkler system piping is a combination of schedule 10 and schedule 40 pipe with either grooved or threaded joints. Observable piping appeared to be in good condition, with evidence of corrosion at various fittings throughout the system.

Evidence of Leaks at Grooved Fittings
