Martha's Vineyard Regional High School, Oak Bluffs, MA
Landscape Existing Conditions Report & Site Development Requirements

EXISTING CONDITIONS - CIVIL ASSESSMENT MEMORANDUM

Re: Marthas Vineyard Regional High School

August 29, 2024

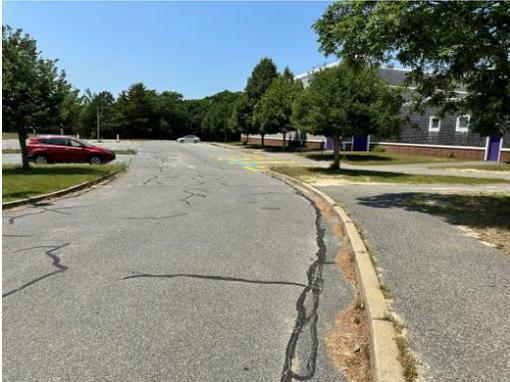
Image 11: Concrete Curb

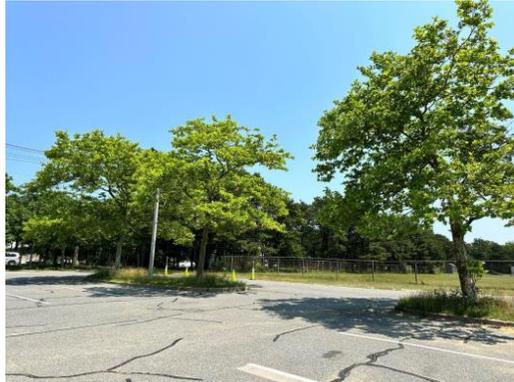
Image 12: Asphalt Patching in Parking Lot

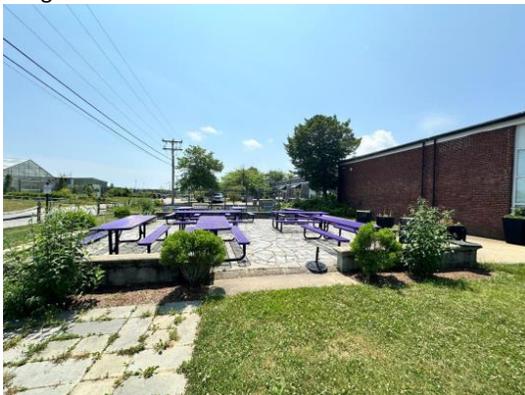
Image 13: Irregular Flagstone in Outdoor Dining

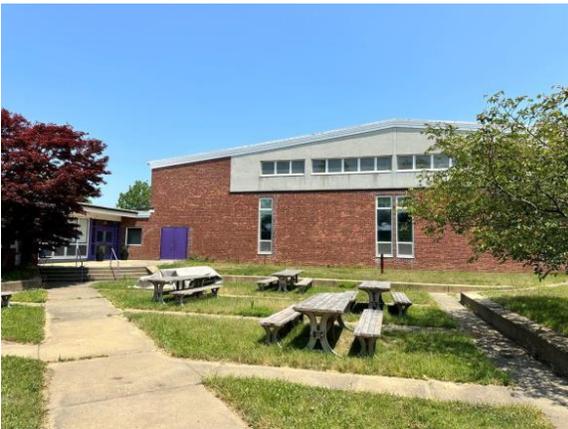
The site is relatively flat with key entrances being accessible. There are some areas such as courtyards that are in poor condition as shown in Image 14 below and some fields do not have pathways to the fields as shown in Image 15.

Image 14: Courtyard walkways

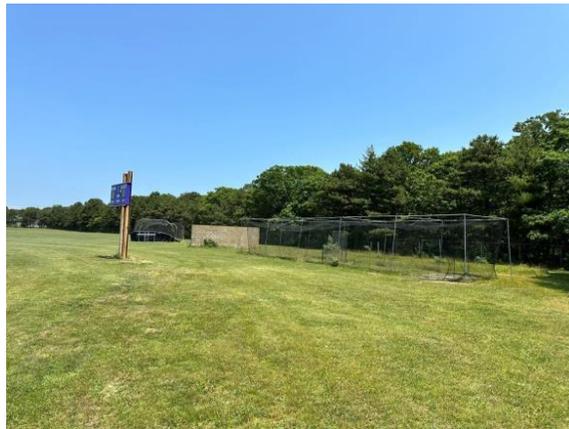
Image 15: No pathway to Softball Field

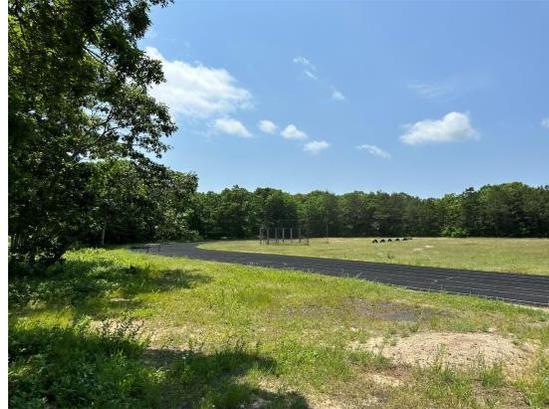
Image 17: Track In Poor Condition

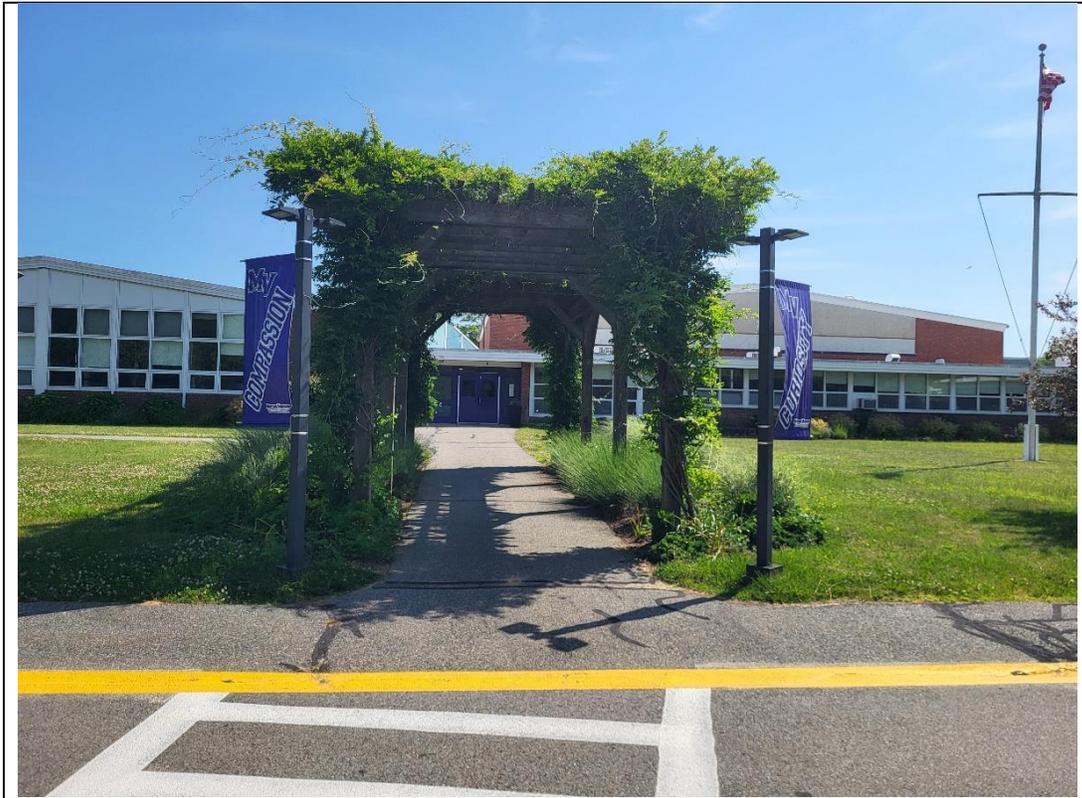
Image 2. Main entrance: signs of lateral cracking in walkway

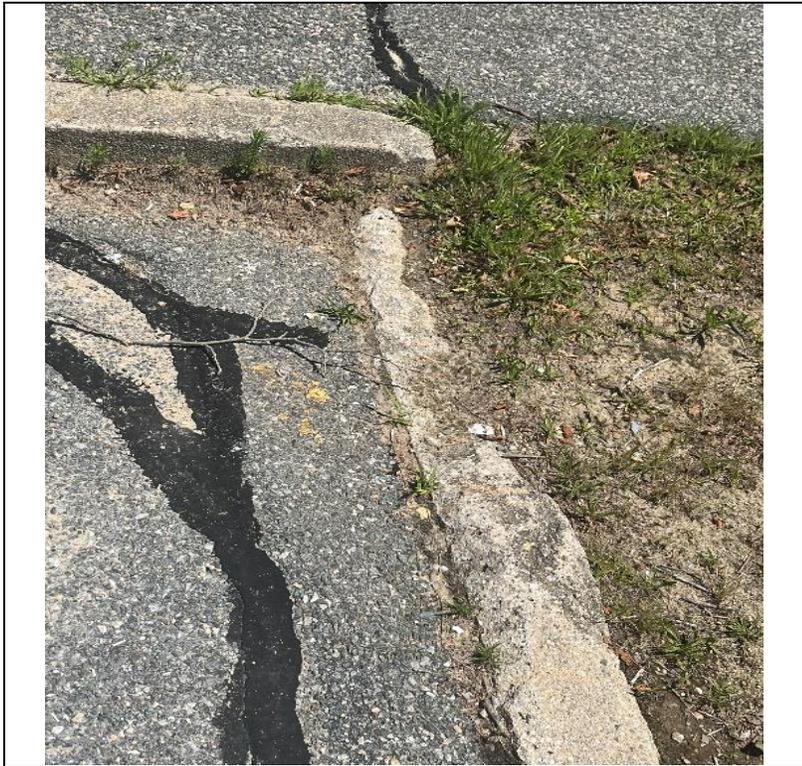
Image 4. Deteriorated curb in main parking lot

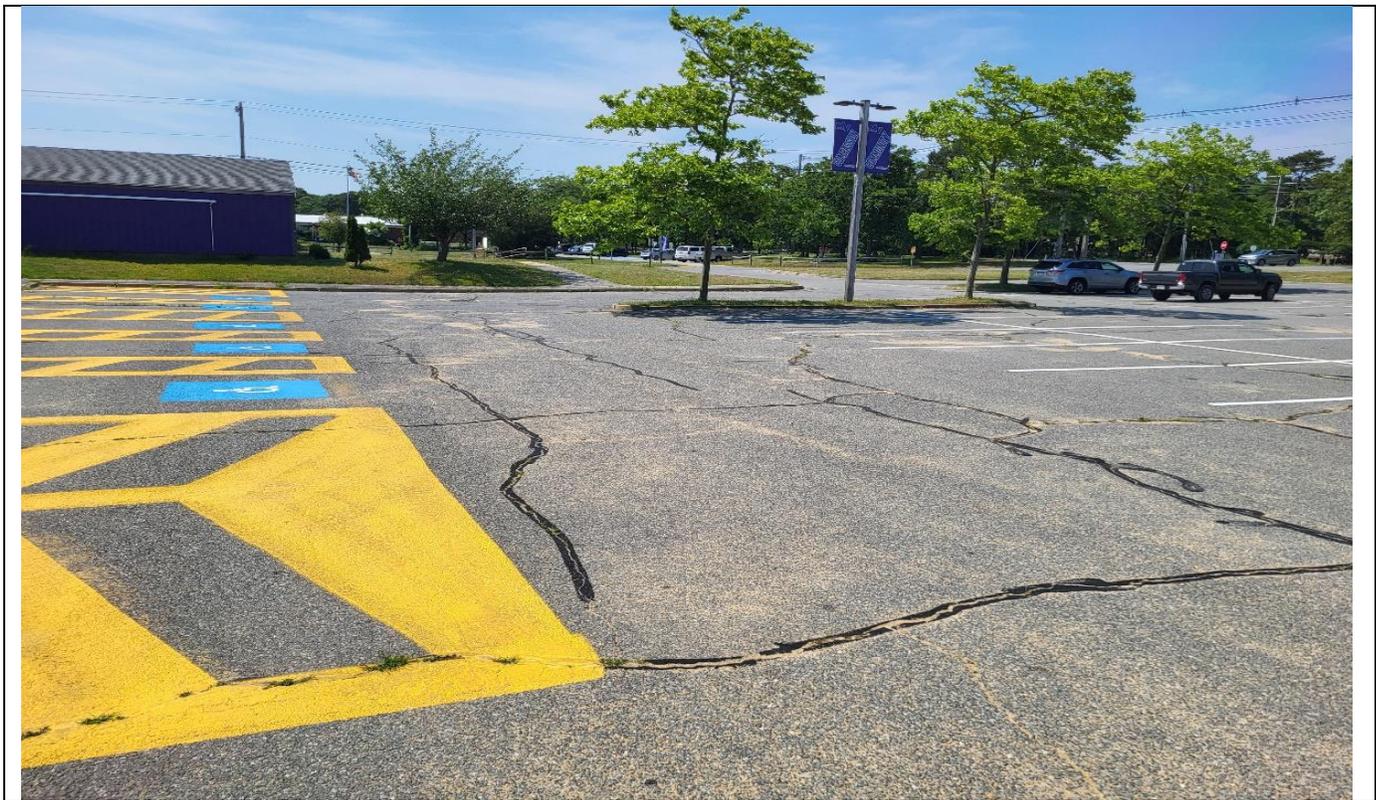
Based on the July 2nd site walk, the on-site parking areas, access drives, and sidewalks, which are primarily asphalt pavement, are in fair to poor condition (see images 5 and 7). Alligator and lateral cracking (i.e. pavement failure) are visible throughout the site. Some curbing is deteriorating and in poor condition (see image 4). It is recommended that representative pavement core samples be taken to confirm the pavement profiles prior to any project redevelopment/expansion.

Image 5. Signs of asphalt failure in main parking lot

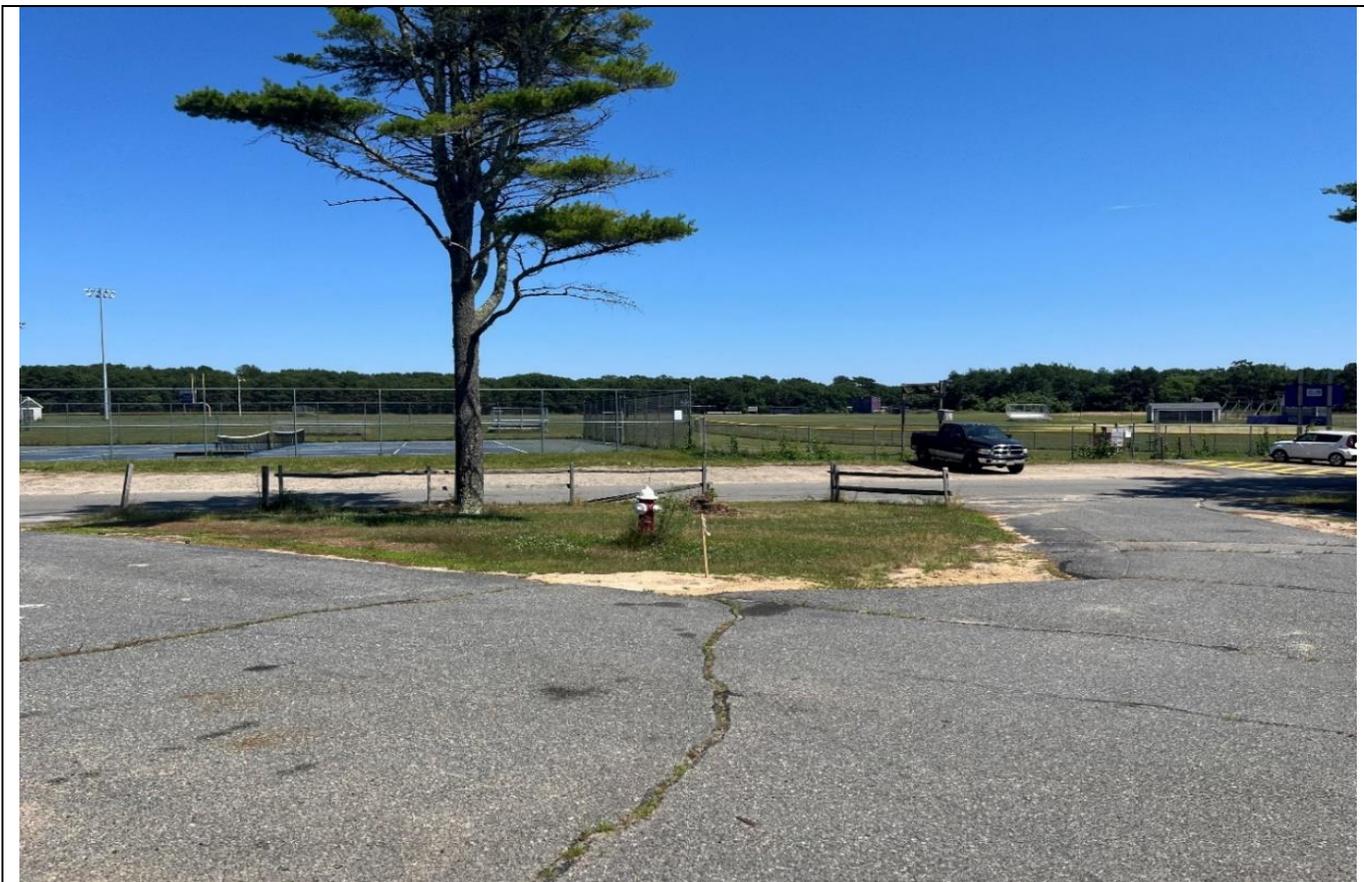
Image 7. Driveway with asphalt failure, no seals. Existing fire hydrant visible,

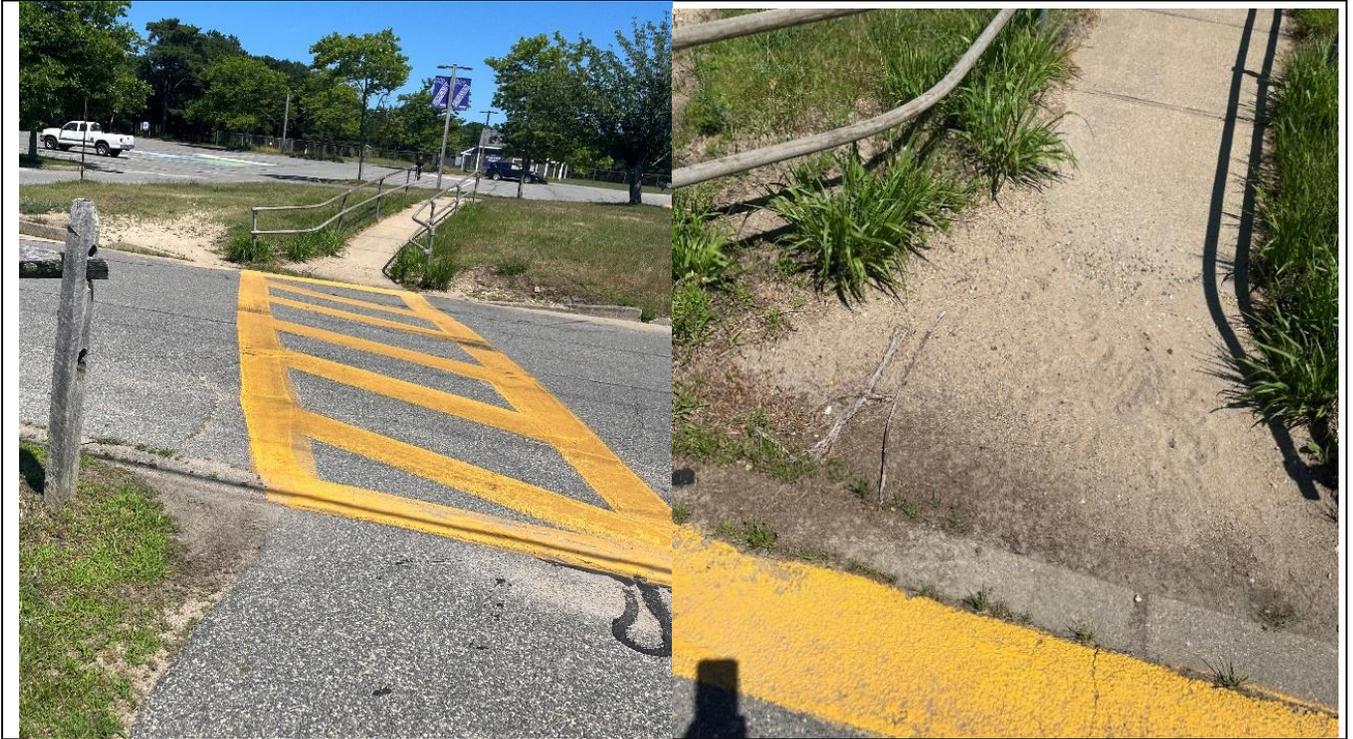
Image 8. Crosswalk with no tactile warning strip present, concrete settling

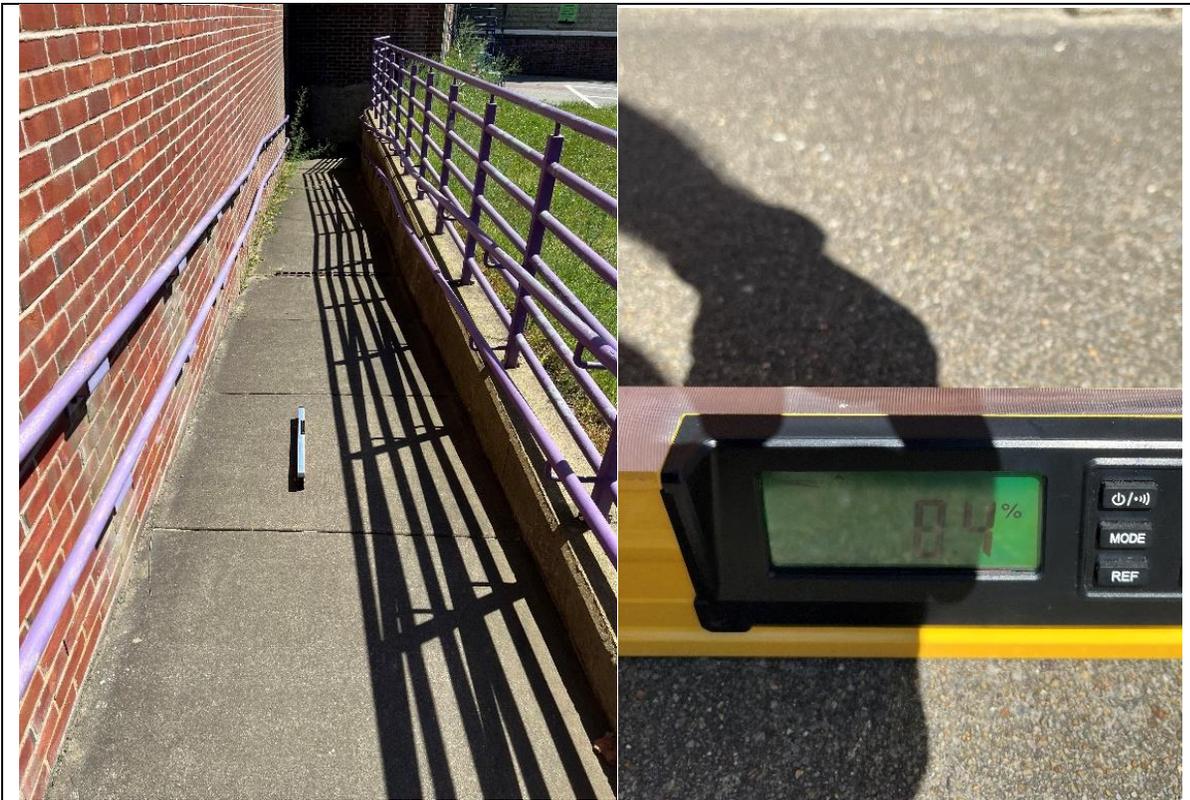
Image 9. Ramp with handrails and slope of 8.4%, slightly in excess of ADA limit of 8.3%

For any future expansion or renovation, it is required to adhere to MAAB / ADA regulations.

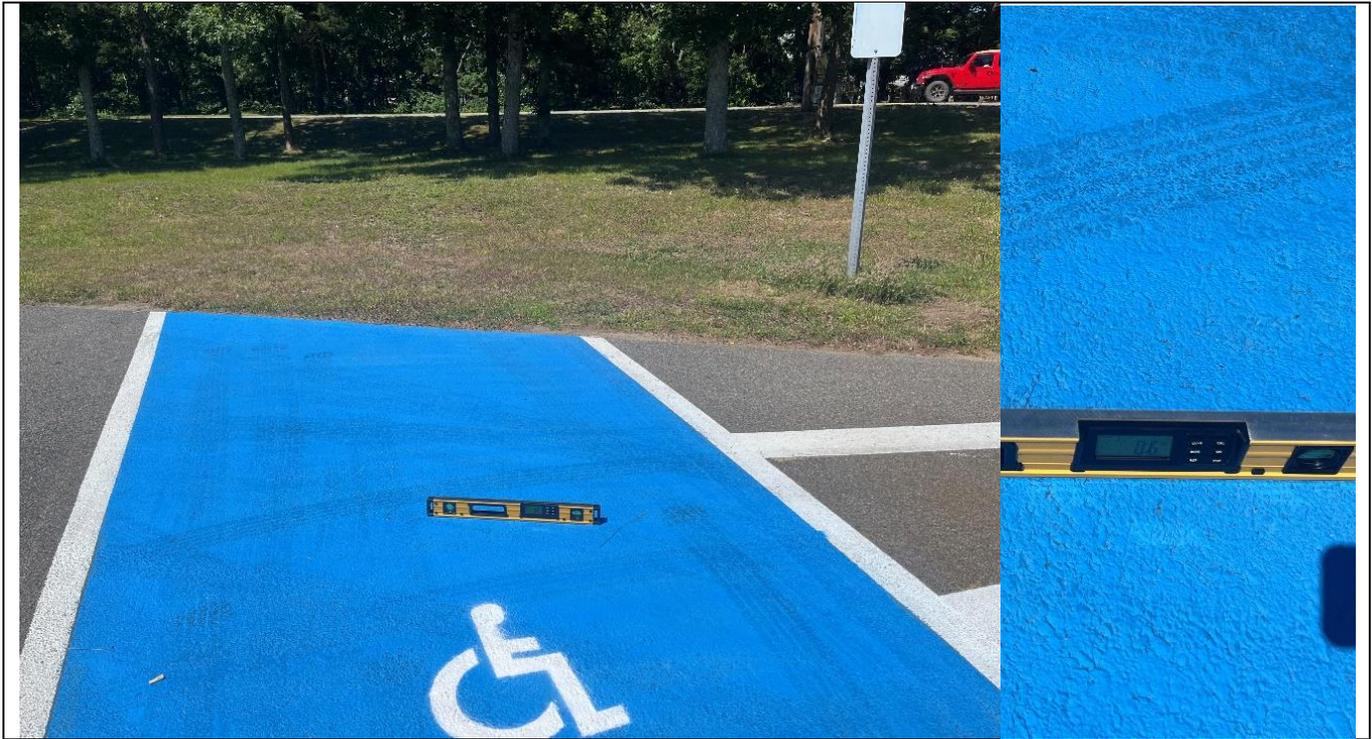
The site is not compliant with most ADA/MAAB regulations regarding the current quality/state of site. Cracks, upheaval, and erosion on the crosswalks/walkways do not provide an ADA accessible transition as part of the pedestrian access way. ADA regulations require that 60% of entrances must be accessible. Some entrances are non-compliant as the slopes exceed the maximum limit of 2% (see images 12-13). Tactile warning pads are missing on sidewalks at crosswalks (see image 8). Accessible parking spaces appear to meet ADA regulations by a smart level check as they do not exceed 2% slope in any direction (see image 10).

Image 10. ADA parking spot gradation of 0.7%, - within ADA standards of 2%.

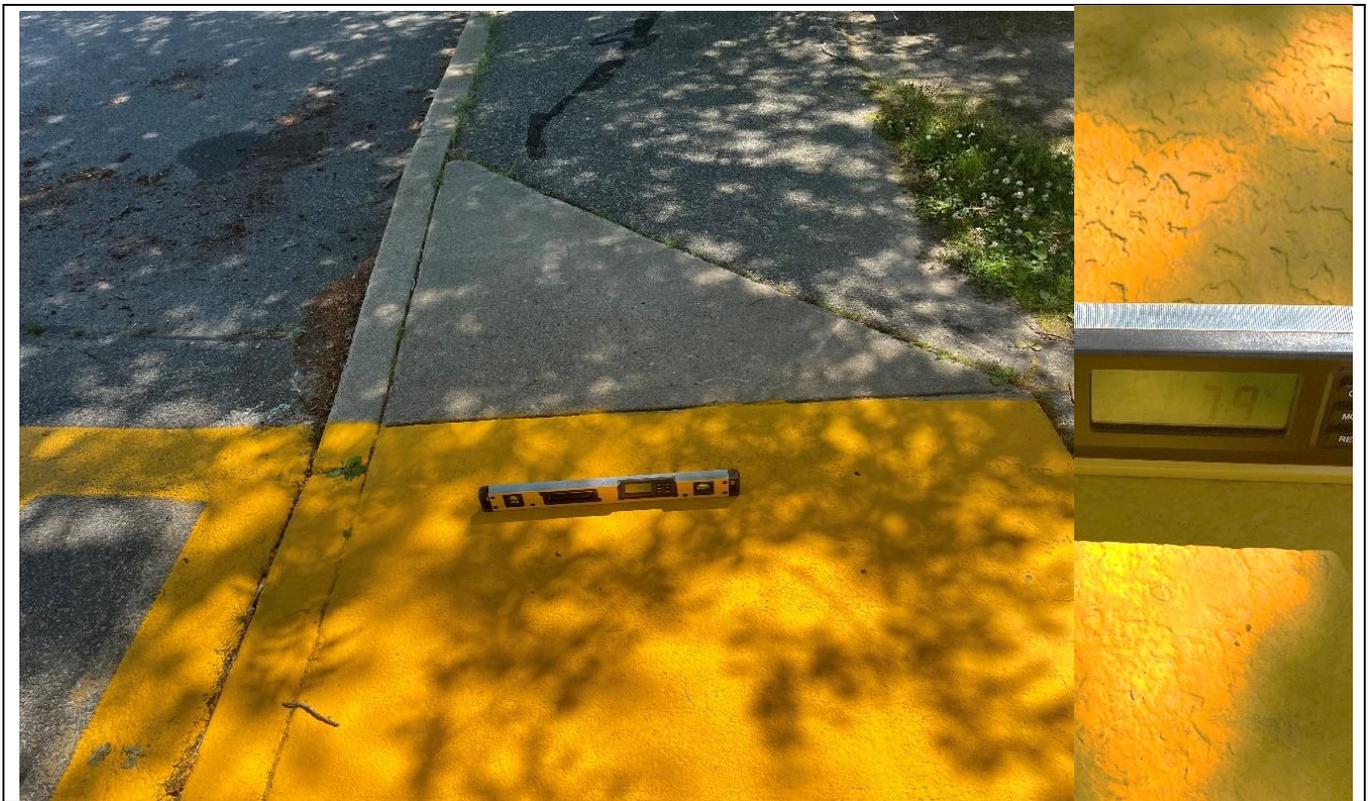
Image 11. Level reads 7.9% at curb cut ramp, which is non-compliant per ADA regulations

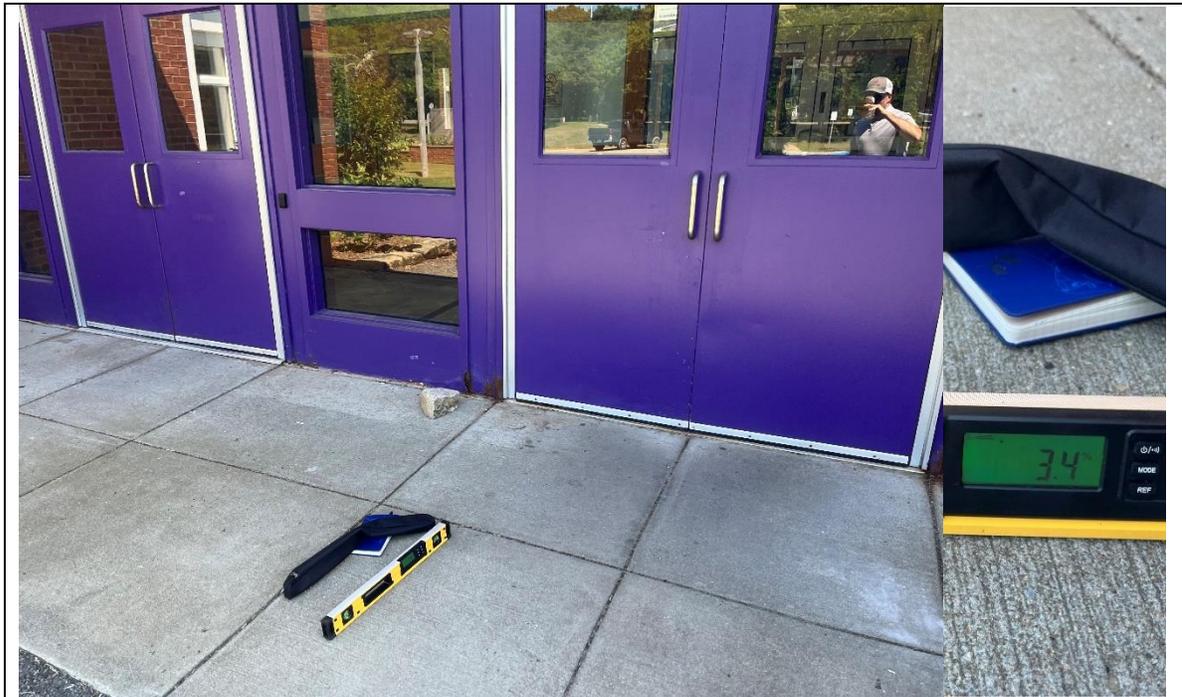
Image 12. Main Entrance: Level reads 3.4% which is non-compliant per ADA regulations.

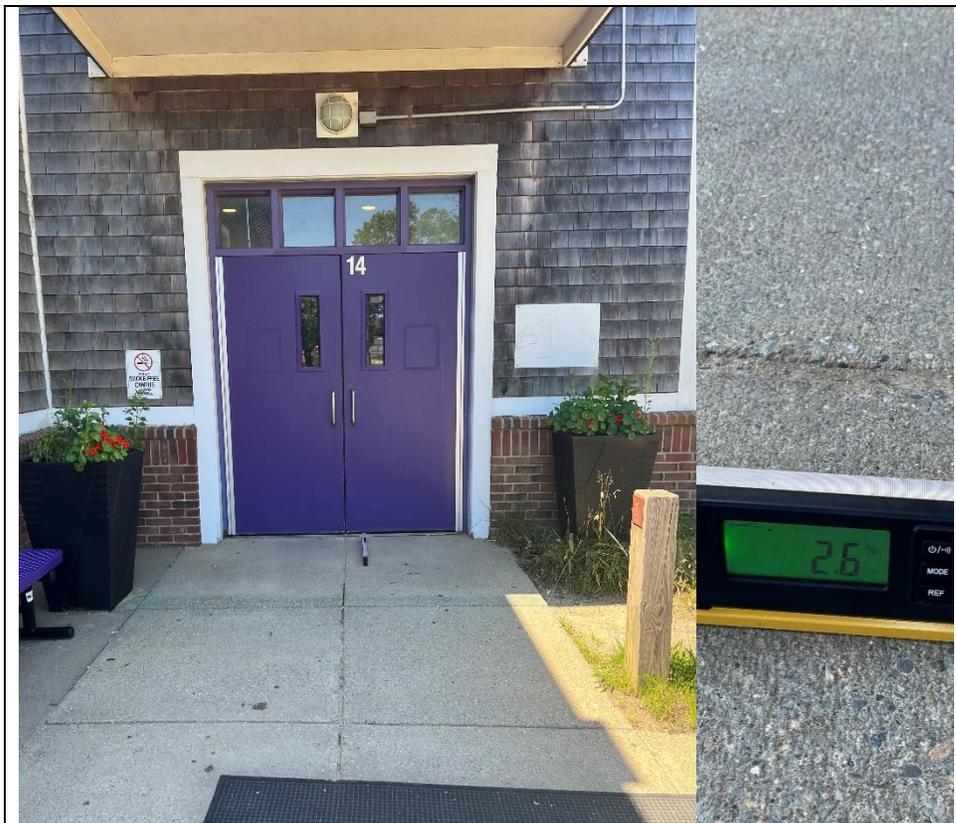
Image 13. Side Entrance slope is 2.6% which is non-compliant per ADA regulations.

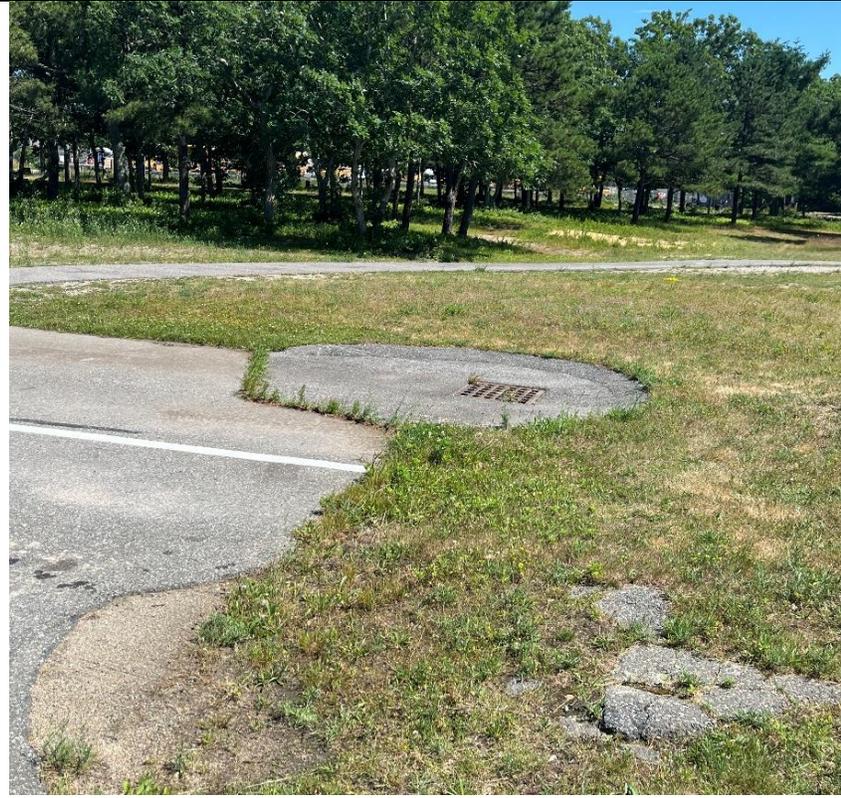
Image 14. Existing catch basin asphalt failing due to ponding

As part of any base repair, renovation and/or program expansion to the site, modifications and/or additions will likely be needed to account for changes in runoff quantities or stormwater conveyance routing. Any upgrades to the on-site stormwater management system will be done in accordance with Massachusetts Stormwater Policy standards. Additionally, any further development will require stormwater management systems (i.e. detention/infiltration system) to mitigate larger rainfall events, as part of any site renovation.

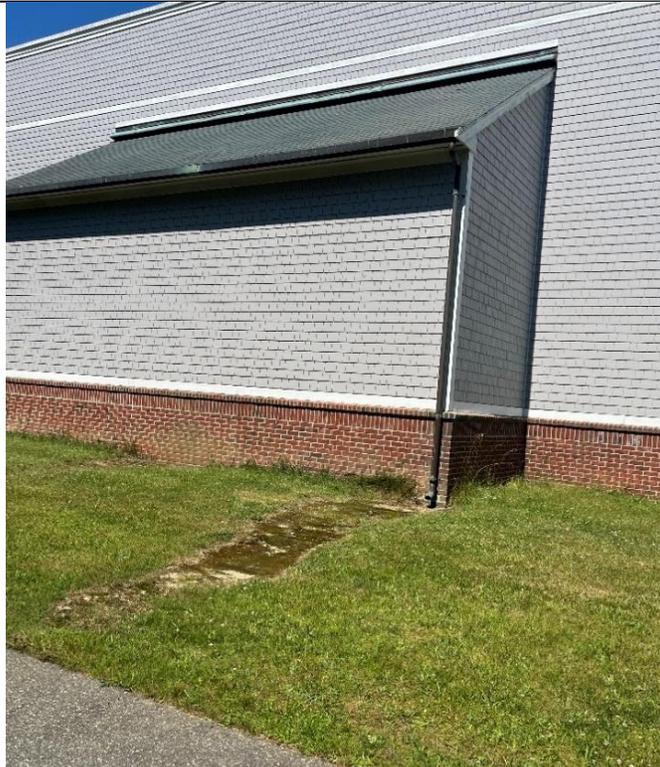
Image 15. Roof leader draining directly to lawn, causing erosion

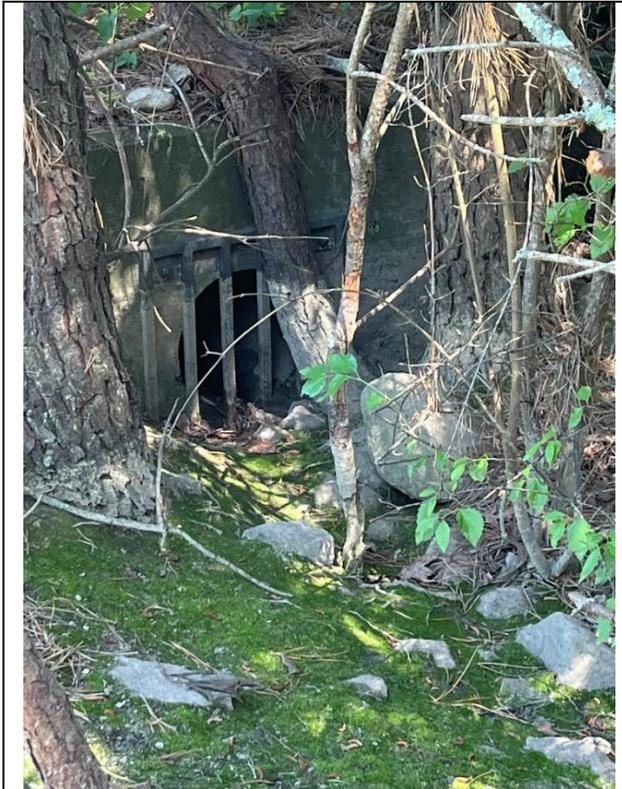
Image 16. Culvert in poor condition with dense growth / vegetation in need of removal / repair

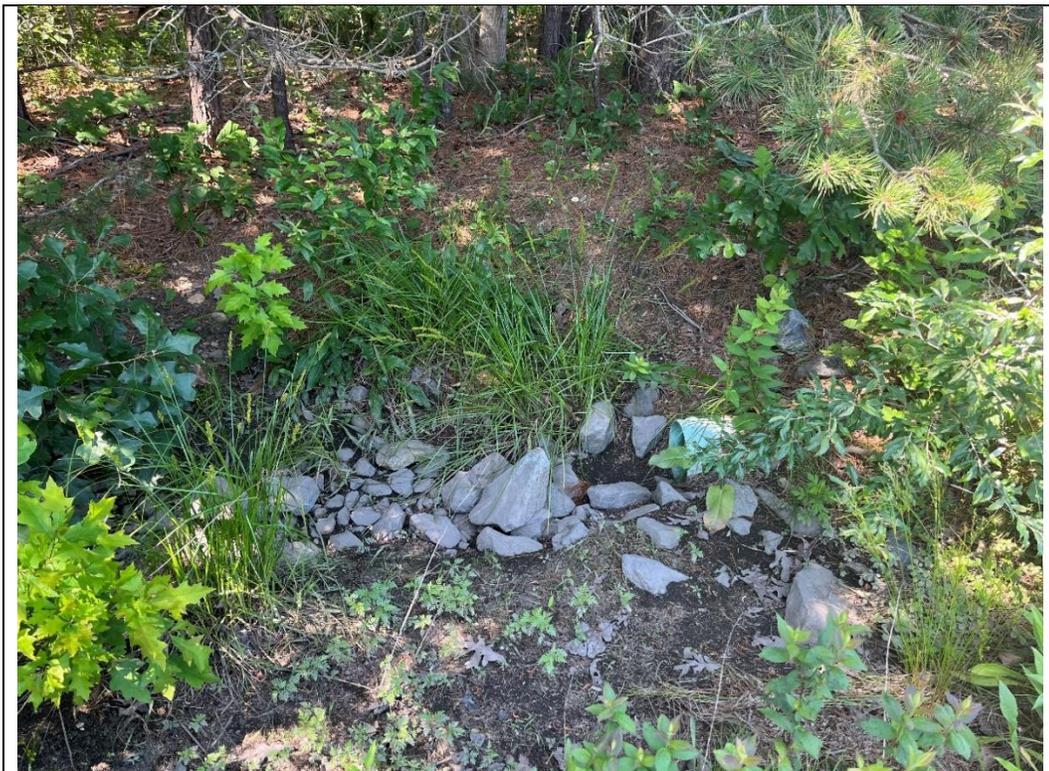
Image 17. Culvert and rip-rap in need of maintenance
