EVALUATION OF EXISTING CONDITIONS

SUMMARY EVALUATION OF EXISTING CONDITIONS

EXISTING CONDITIONS | BUILDING CONDITIONS

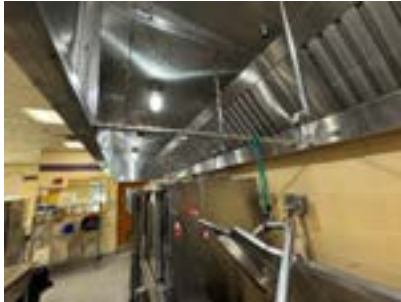
- The Kitchen has a Type I exhaust hood and a Type II dish exhaust hood. This equipment runs continuously though Kitchen operation is only a portion of the day. The equipment is in good condition but past the expected service life.
- The Culinary Kitchen is served by an AHU with overhead duct distribution and supply grilles. The AHU provides heat and ventilation and is located in a mezzanine with limited service access. The AHU is original to the 1992 renovation and past the expected service life.

Main Kitchen Type I Exhaust Hood

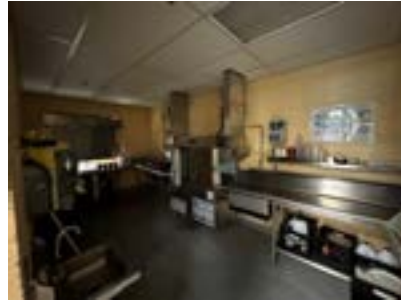
Main Kitchen Type II Exhaust Hood

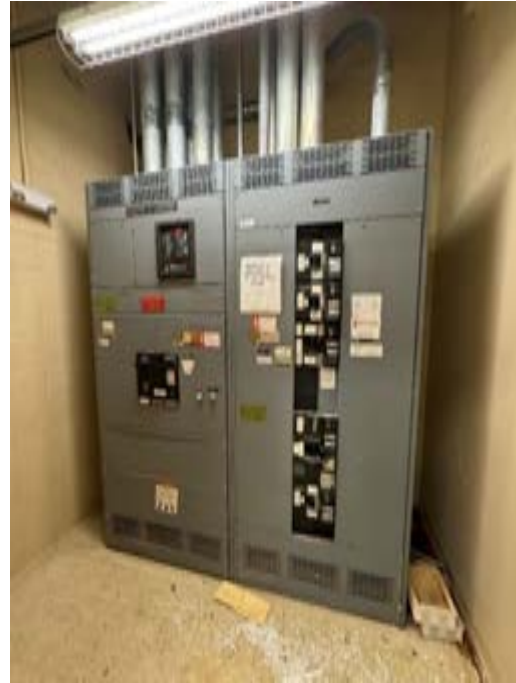
Switchboard #3 (480Y/277V, 2000A)

- The 480Y/277V, 3-phase, 4-wire 2000-amp service is in a dedicated electrical room. This switchboard (Switchboard #3) is from the 1990s and is in good to fair condition. This serves HVAC loads, panels and Outbuilding power. This feeds the normal side of the automatic transfer switch. The actual capacity of the service needs to be verified by the utility provider.

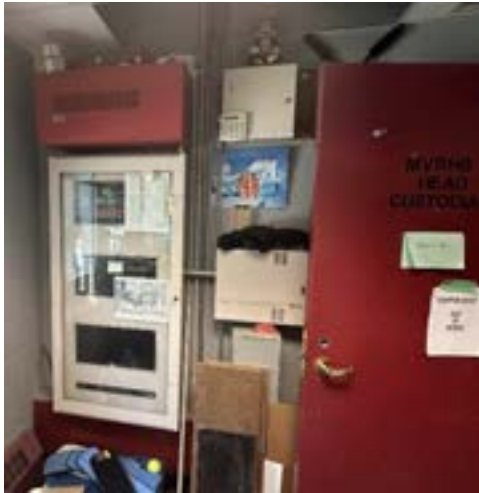
- The fire alarm system is a Simplex 4100 located in the Janitors Room in the back of the building. This is an addressable panel but not set up for voice evacuation. Microphone nor drill switch were observed. Some horn/strobes are located in the building. Toilet rooms have strobes. Air handling units have duct smoke detectors where required. Devices appear to be original to the building. Sound systems do not turn down upon activation of the fire alarm system. Devices appear to have been code compliant at time of installation but are not compliant with current code. The system is recommended to be upgraded.

Fire Alarm Control Panel

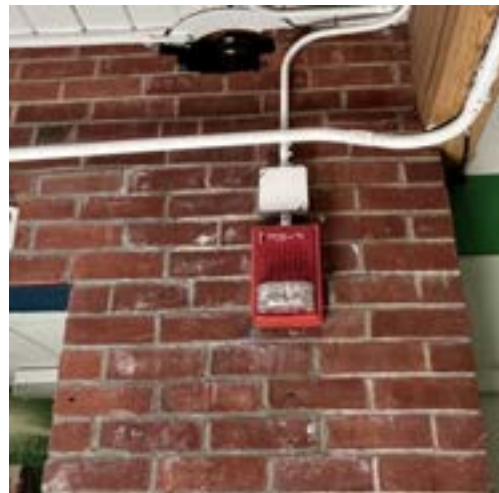
Fire Alarm Annunciator and Device

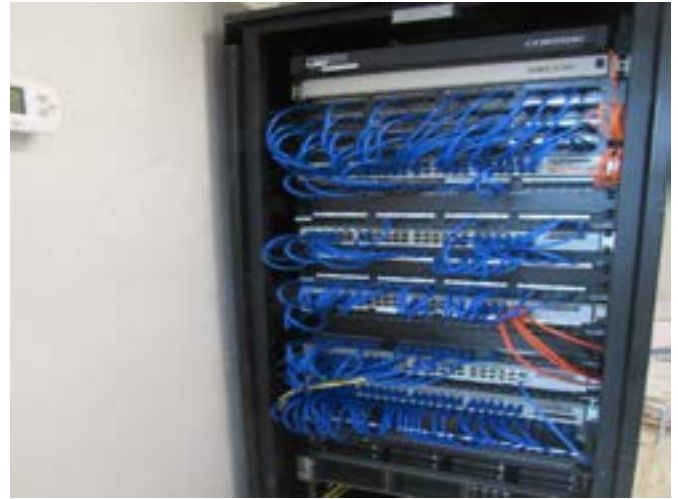
MORE CLEAN CABLE INSTALLATION

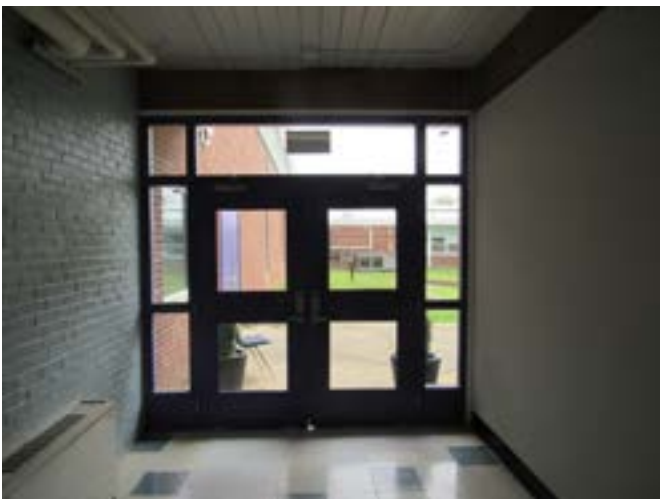
NO PERIMETER DOOR MONITORING.

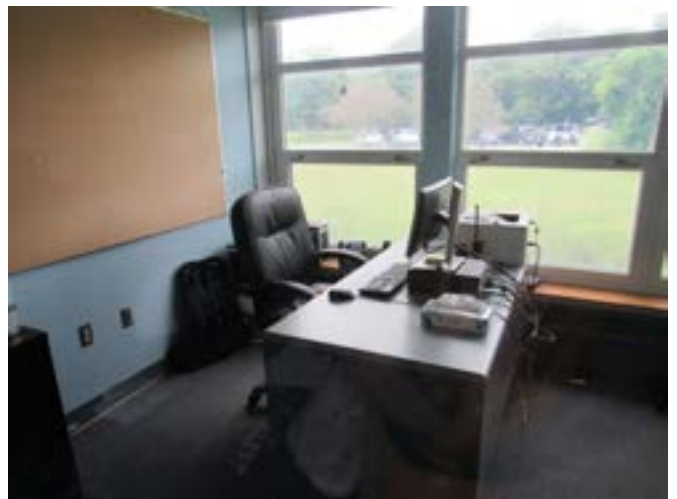
SRO OFFICE WITH EXTERIOR VISIBILITY.

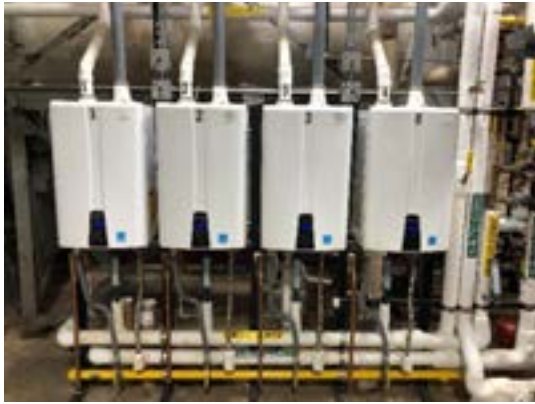
Gas-Fired Water Heaters

The domestic water heating plant is located in the mechanical room and consists of four (4) Navien gas-fired high efficiency wall hung water heaters. The domestic hot water is a dual-temperature system (120°F and 135°F) with a Leonard high-low mixing valve stations and recirculation pumps. The piping around the water heaters, pumps, and mixing valves is in good condition. The water heaters' combustion air and exhaust gas vent piping appear to be schedule 40 and schedule 80 PVC respectively, and terminate through the roof.

The water heaters are in good condition and could remain in service.

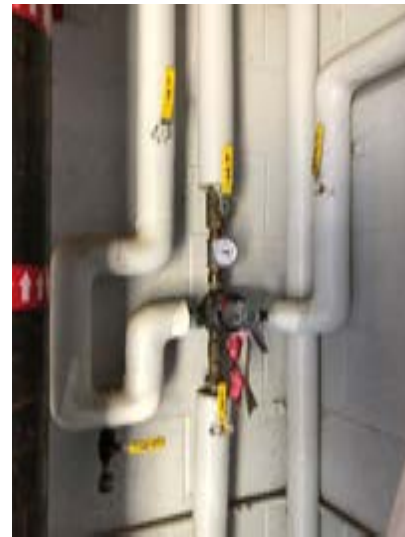
Exterior Mech Room Mixing Valve

There is a thermostatic mixing valve located in the exterior mechanical room in the shop area. It is unclear at this time what fixture(s) this valve serves, but we suspect it provide tempered water to the emergency safety stations.

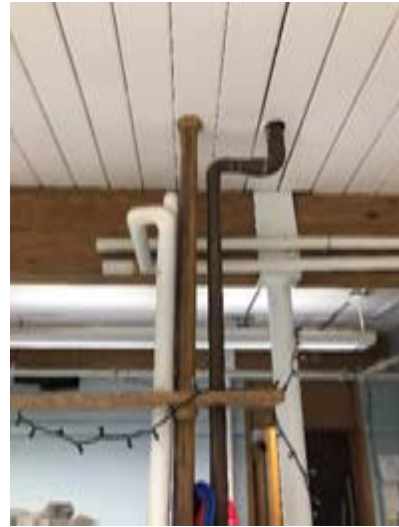
Copper Vent Pipe

What could be seen of the existing sanitary drain, waste and vent system appears to be a combination of drainage pattern copper, cast iron, and galvanized steel. The majority of the piping is hub and spigot cast iron with either gasketed or leaded and caulked joints, with some no-hub cast iron pipe with rubber couplings and stainless steel bands with shields. Copper drainage piping is limited primarily to fixture connections. Galvanized steel appeared to be limited to vents only. Visible piping appeared to be in good condition, with little evidence of active leaks.

Although the storm and sanitary drainage system piping appears to be in good condition, a minimal amount was visible during our visit, therefore extensive investigation should be conducted prior to reuse or

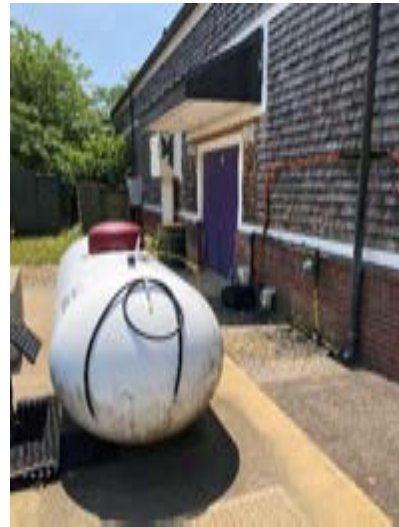
LP Tank and Piping

The building is equipped with multiple exterior LP tanks located sporadically around the building. The tanks serve the kitchen, culinary arts, domestic water heaters, and science classrooms. The kitchens and science classrooms appear to be equipped with emergency gas shutoffs, although the kitchen system may not be interlocked with the kitchen exhaust and does not have a manual shutoff. Gas piping is steel with pressed or threaded fittings, and appears to be in good condition.

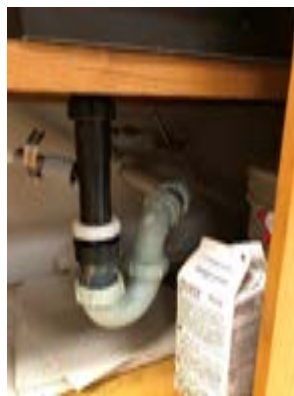
Lab Waste Piping

The science classrooms are equipped with a laboratory waste and vent system. Neither an acid waste neutralization system nor a non-potable water source were encountered. The laboratory waste piping system appears to be polypropylene with mechanical fittings. Visible piping appears to be in good condition.

The existing laboratory acid neutralization system should be evaluated and modified as required. Depending on the chemicals in use, the system may need to be equipped with a chemical injection type system. All acid waste and the sump discharge piping should be investigated for deterioration.

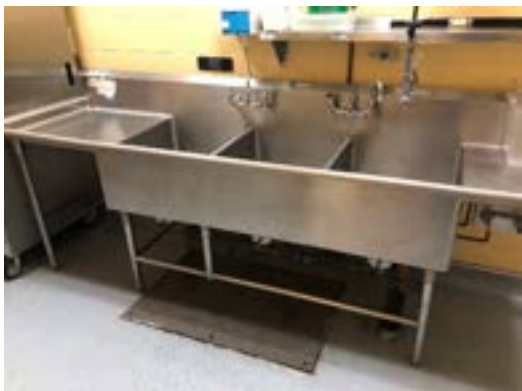
Scullery Sink w/Recessed Grease Interceptor

- Plumbing fixtures appear to be in good condition, but may not meet current codes for flow rates and/or accessibility.
- Grease traps do not have proper signage.

All deficiencies noted above should be addressed.

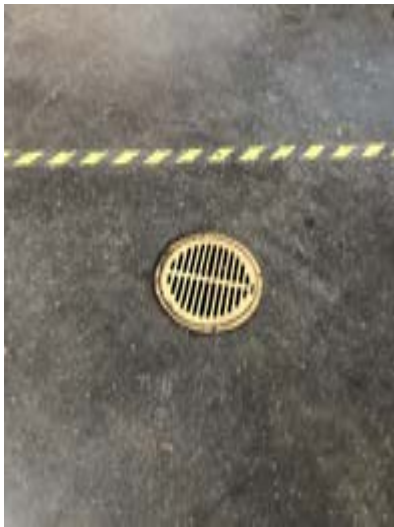
Auto Shop Area Drain

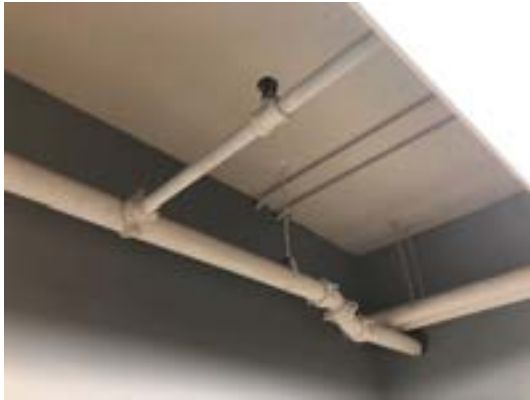
Sprinkler system piping is a combination of schedule 10 and schedule 40 pipe with either grooved or threaded joints. Observable piping appeared to be in good condition, with evidence of corrosion at various fittings throughout the system.

Upright Sprinkler & Piping

In addition, the system should be flushed and internally inspected for obstructions, and corroded fittings should be replaced.

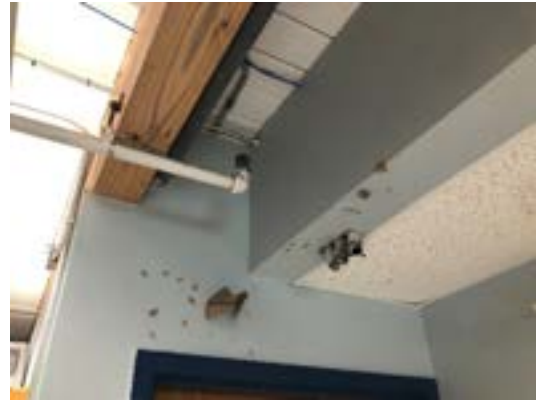
Upright Sprinkler – Soffit Obstruction

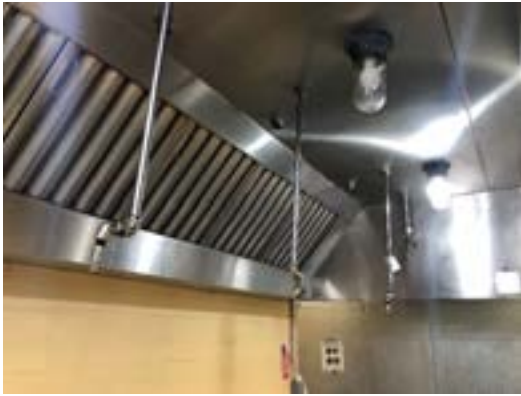
The existing kitchen hoods are equipped with integral chemical type fire suppression systems.

Kitchen Hood Suppression

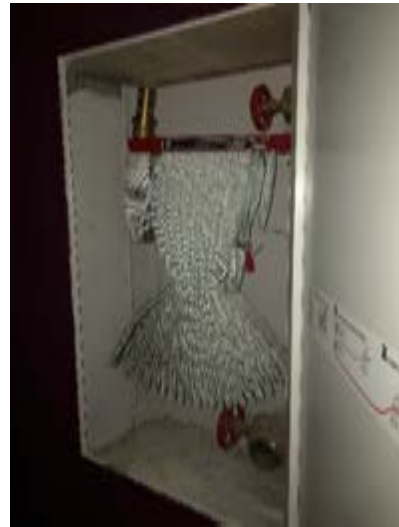
The stage is equipped with fire hose stations on each side of the stage. The proscenium opening appears to be protected with a fabric curtain.

Hose Station at Stage
