Martha's Vineyard Regional High School, Oak Bluffs, MA
Landscape Existing Conditions Report & Site Development Requirements

EXISTING CONDITIONS - CIVIL ASSESSMENT MEMORANDUM

Re: Marthas Vineyard Regional High School

August 29, 2024

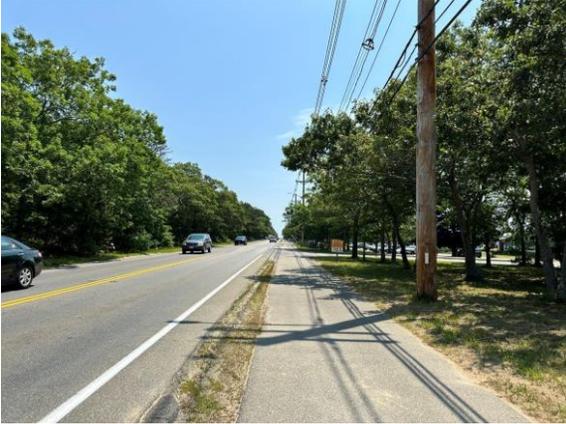
Image 1: Primary Entrance Road To School

The existing site is relatively flat. A mature grove of trees buffers the drop-off and parking at school entrance from the Vineyard Haven Road as shown in Image 1. Parking areas are distributed around the site. Parking quantities are shown on the Site Analysis Plan. A driveway loops around the school that provides service and emergency access.

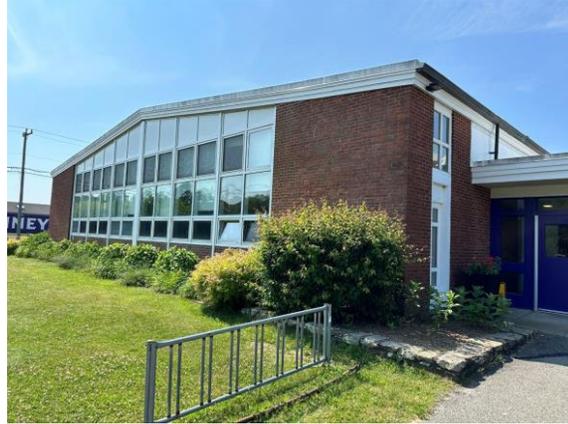
Image 2: Main School Entrance

There are pedestrian walkways between parking and drop off areas and the building entrances. In general, accessible routes do not exist to most athletic facilities. There are two courtyards that are accessed from inside the school. All the pedestrian connections are predominantly asphalt including the drop-off walkways and main entrances as shown in Image 2.

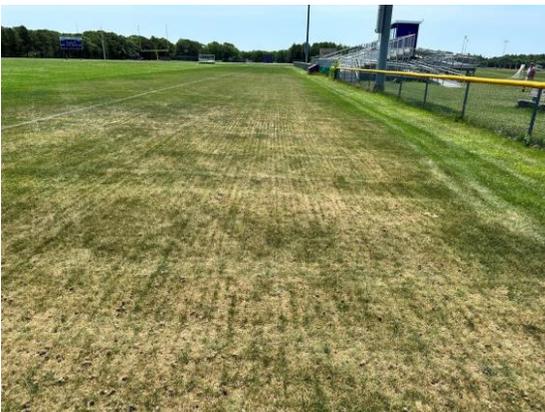
Image 3: Fencing For Football Stadium

Currently a large grove of trees on the landscape island as shown in Image 1 serves as a barrier to the main entrance plazas. The fencing exists by the stadium field as shown in Image 3 and the pro-baseball league field as shown in Image 4. The tennis courts also have fencing. The rest of the fields do not have any fencing. There are no retaining walls on site. There is a student-built wood pergola by the main entrance as shown in Image 5. There are some split-rail fences providing barrier in outdoor gathering space like the cafeteria as shown in Image 6.

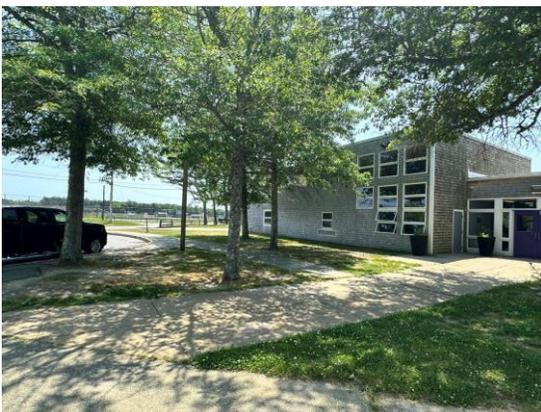
Image 7: Concrete pedestrian connections

The pedestrian connections within the campus are primarily narrow concrete pathways as shown in Image 7 or asphalt walkways along the roadways. There are some stone dust pathways in the courtyard as shown in Image 8.

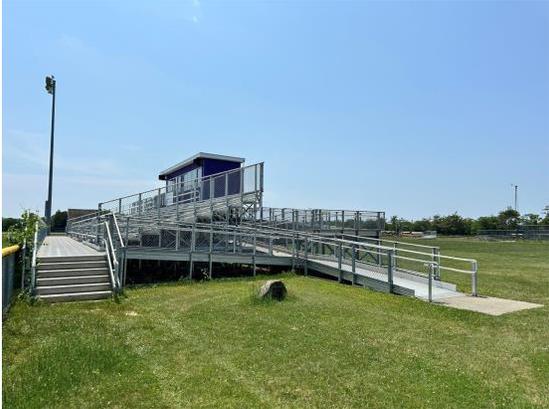
Image 16: Football Stadium Bleachers

All the athletic fields are natural grass and there is no synthetic turf. The football stadium is in good condition with scoreboards, sports lighting and a compliant bleacher with press box as shown in Image 16. The track is separate from the stadium and is in poor condition as shown in Image 17. The softball field infrastructure is in poor condition as shown in Image 18. The tennis courts are not accessible and in poor condition as shown in Image 19. The MV Sharks baseball field is in good condition with stadium seating and other amenities as shown in Image 20. It has

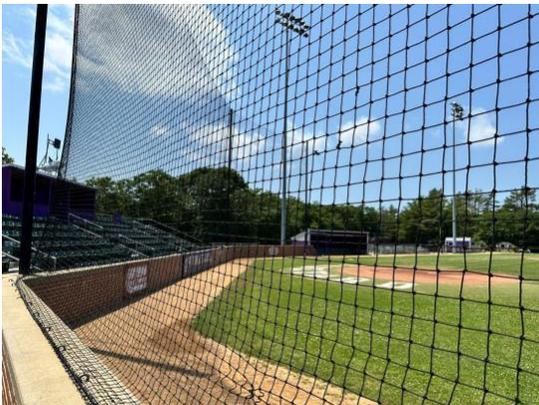
Image 20: Pro-Baseball Stadium

all the necessary infrastructure from fencing, scoreboard, sports lighting, bleachers and concession.

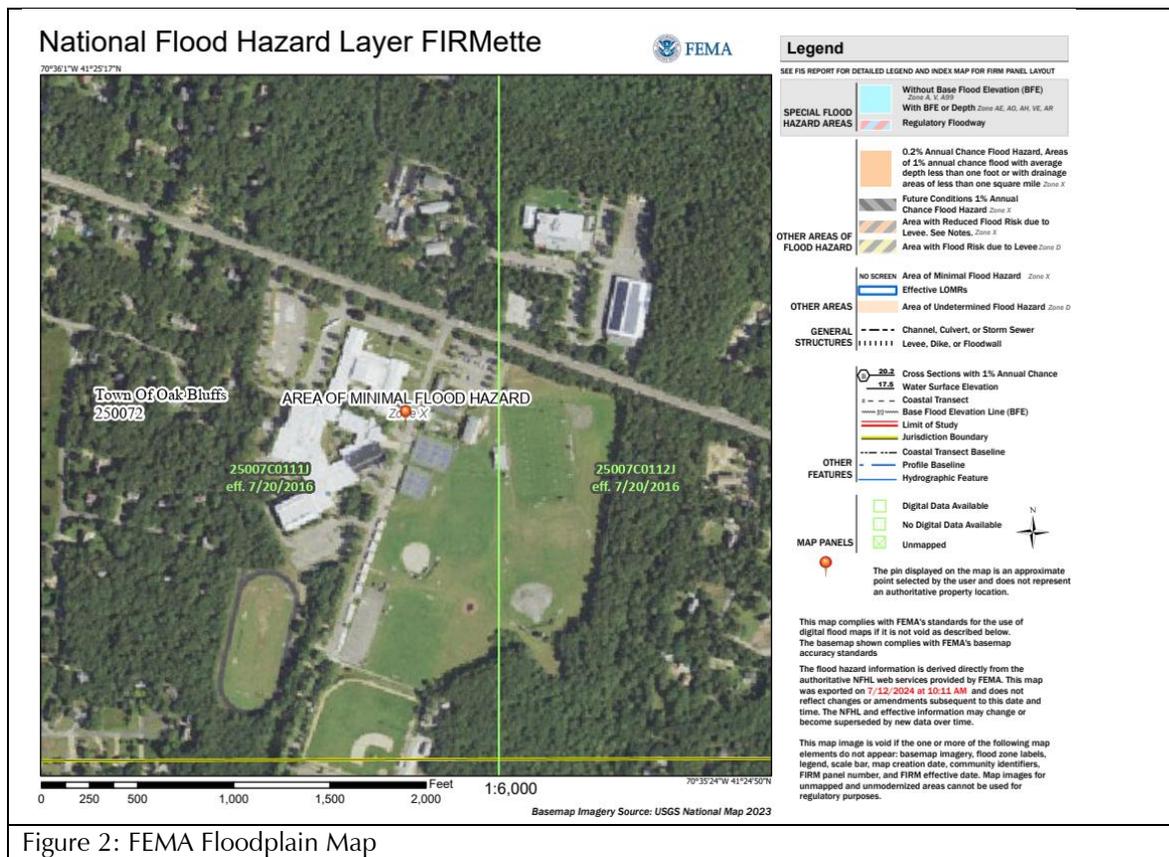
Figure 2: FEMA Floodplain Map

According to the current FEMA Flood Insurance Rate Map (Figure 2), the site is not located within a regulated flood plain and is in an area of minimal flood hazard.

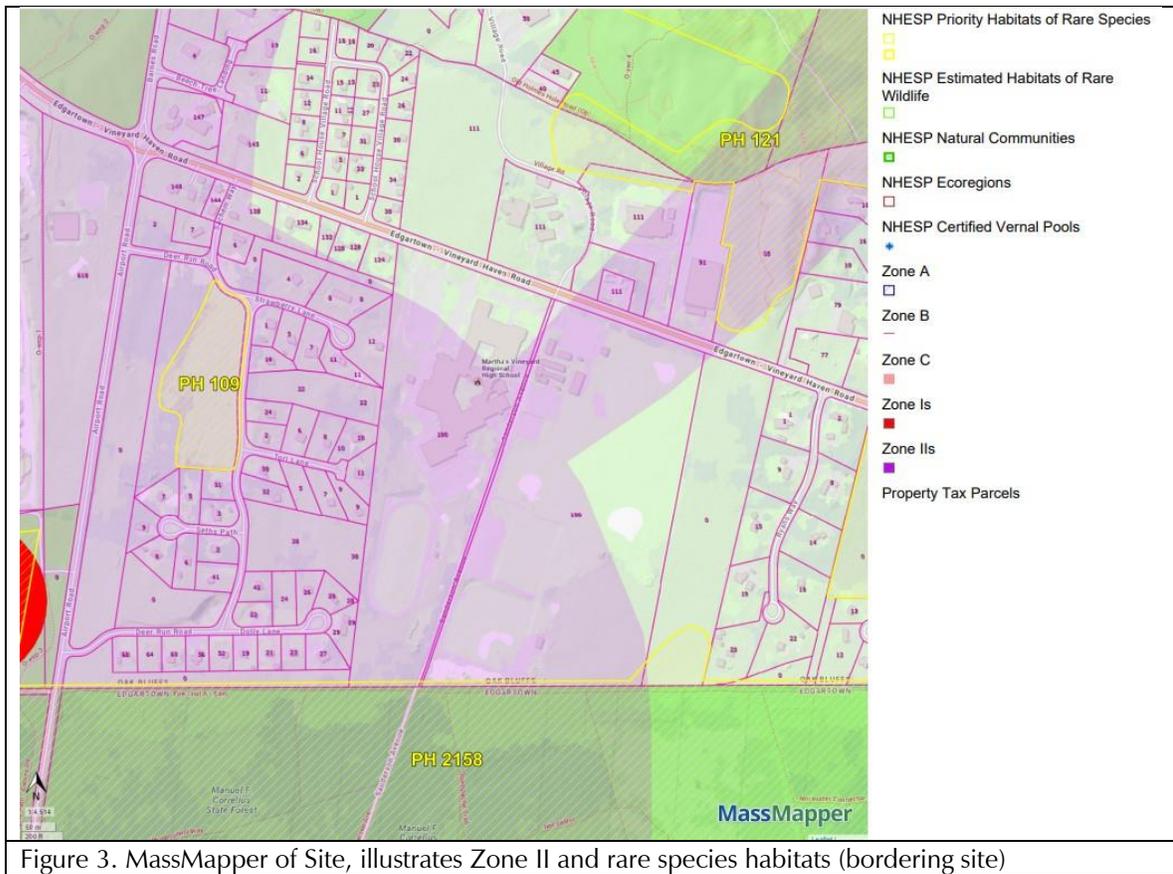
Based on a desktop review (MassMapper and the Town GIS), potential wetland resource areas appear to be located on the site. Wetland resources are subject to jurisdiction under the Massachusetts Wetlands Protection Act and the Oak Bluffs Wetlands Protection Bylaw. There exists an approved Wellhead Protection Areas (Zone II) Area covering about 70% of the site. (See Figure 3)

Zone II well head protection areas impose restrictions on materials that can be stored within the area or underground (including storage tanks, hazardous substances, septic systems, etc.), the types of activities that are allowed within them (these restricted activities include auto repair, etc.) and the amount of treatment required for the impervious area within them. The MA DEP Water Resources Section may be involved in any permitting for work within a Zone 2, but likely only the final condition, not temporary under construction conditions. Additionally, stormwater discharges within the Zone II of a public water supply or to any other critical area require the use of the specific source control and pollution prevention measures and the specific structural stormwater best management practices

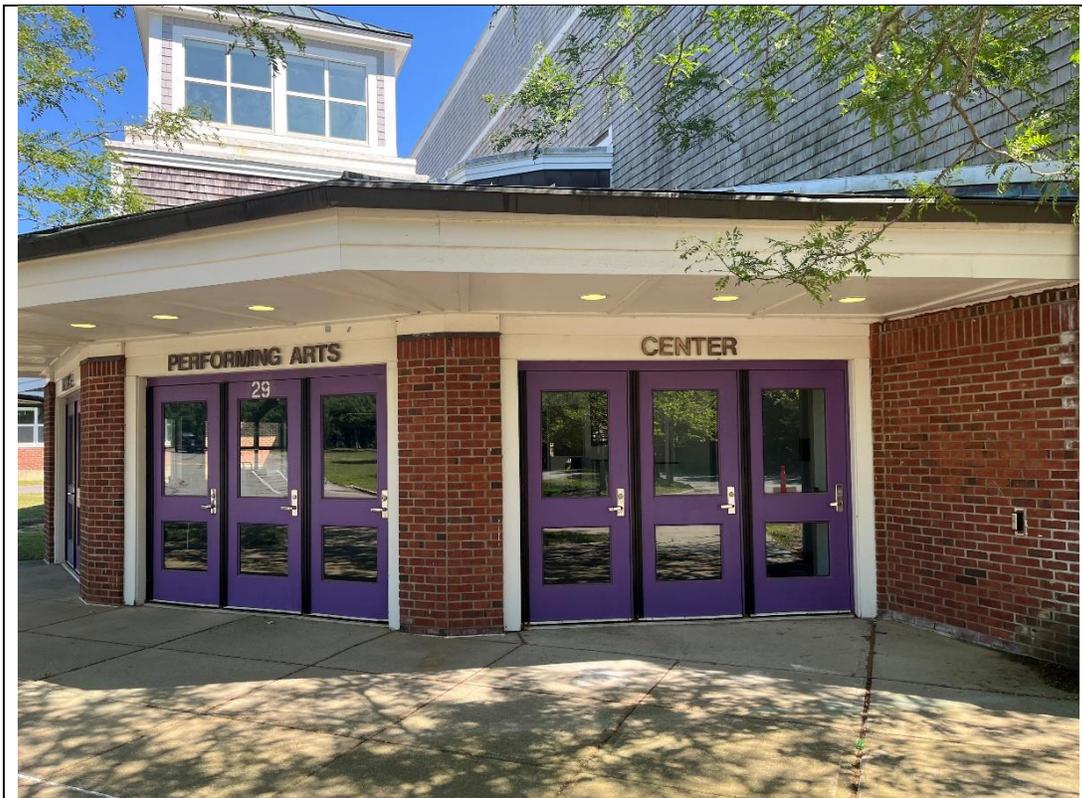
Image 3. Entrance to the Performing Arts Center

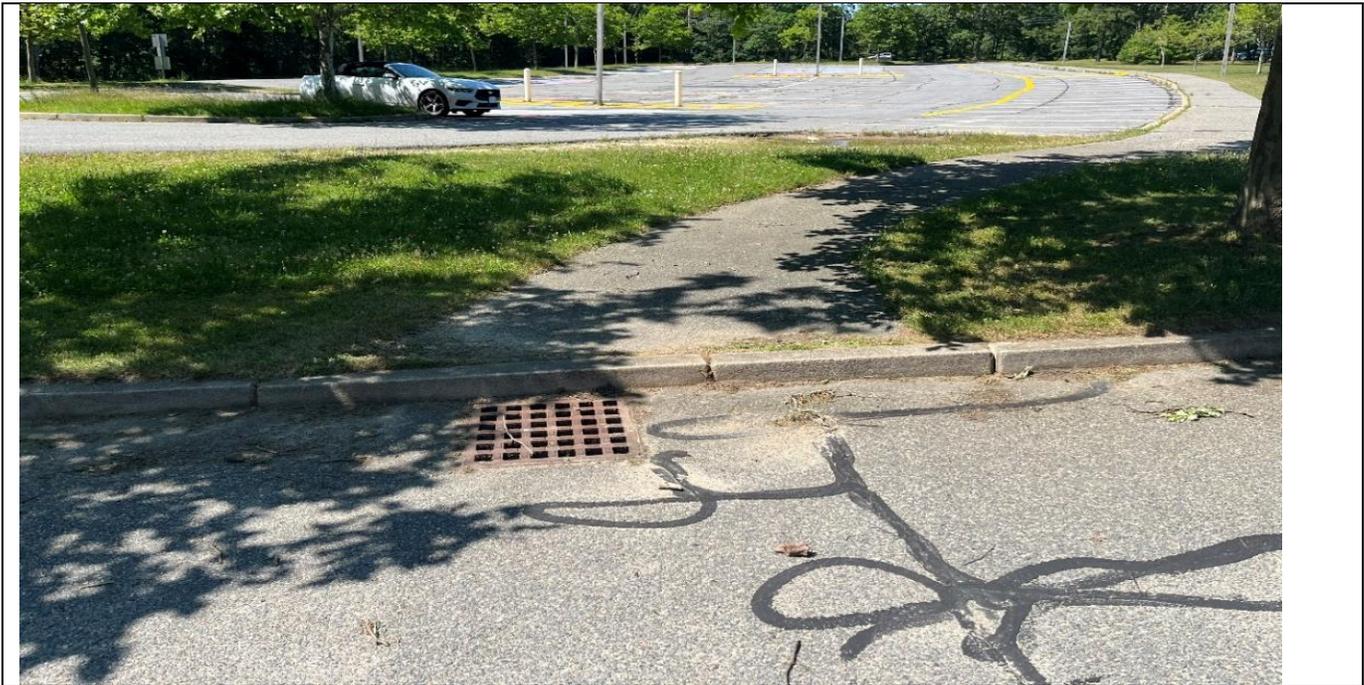
The existing on-site stormwater conveyance system, according to the 1994 record drawings, consists of a series of 20-22 catch basins, leaching basins, and leaching catch basins located throughout the site within the driveways and parking areas (see images 6 and 14). Some of these catch basins are "daisy chained" together (i.e. connected directly to each other rather than through manholes). This "daisy chain" configuration tends to have a higher rate of failure and/or causes inefficient stormwater conveyance. Catch basins connect to between one (1) to four (4) leaching basins using 12" drain piping.

Image 6. Existing Catch basins along entry drive
