EVALUATION OF EXISTING CONDITIONS

SUMMARY EVALUATION OF EXISTING CONDITIONS

EXISTING CONDITIONS | BUILDING CONDITIONS

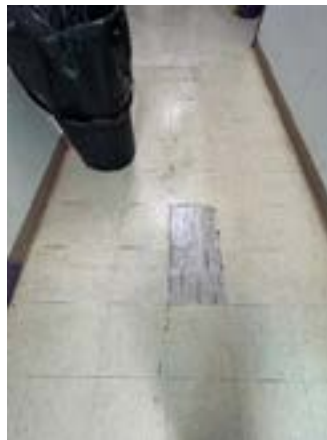
Flooring is predominately VCT in all classrooms and public spaces. There is carpet in the administration areas and in the library, there is a mix of carpet and LVT. Some of the flooring has been replaced as asbestos abatement has been happening periodically. The flooring in the main kitchen and CTE spaces is concrete. The flooring in the Culinary Arts kitchen is tile. The ramps connecting the different additions have rubber flooring. The flooring throughout the building is worn.

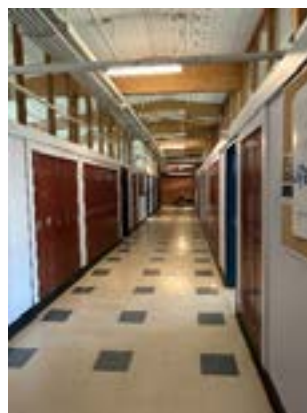
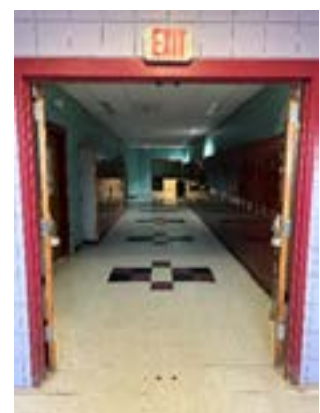
The casework throughout the building (especially in the science labs) should be replaced. The science labs have reported unsafe storage conditions and other areas are showing signs of general wear and tear. Fixed lab stations in the middle of the classroom reduces flexibility and can create congestion. Renovation considerations must include casework upgrades to meet MAAB requirements. In addition to the replacement of casework, any future project should consider the actual utility of the metal lockers located throughout the building. To replace the lockers with a more appropriate size unit would be costly and it is reported that the sprawling nature of the high school the lockers are not used particularly well and are hard to get to in the short amount of time between classes. Removing lockers could allow for space saving design changes and more space in classrooms or directed toward 21st century learning initiatives.

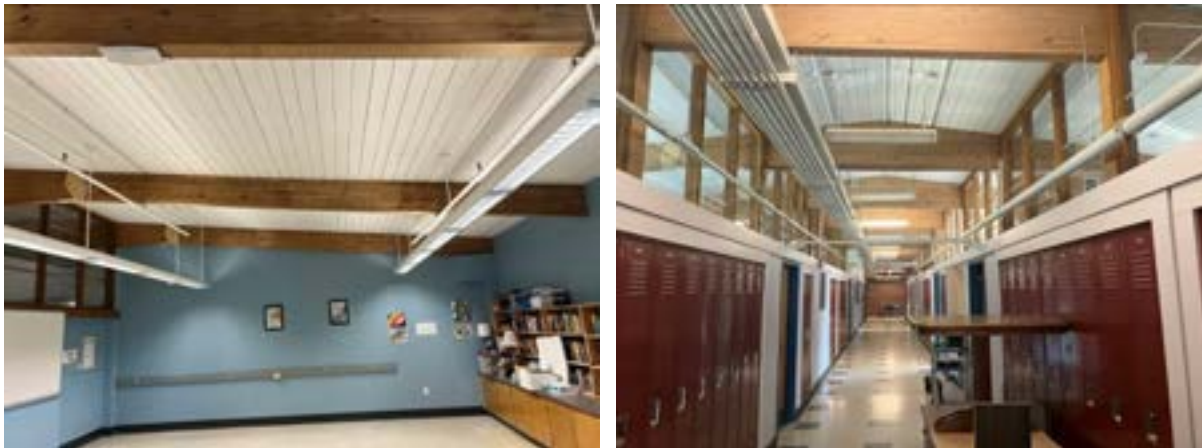
Typical Roof Framing of the Original Structure

Based on our observations, majority of the school structure is in good condition and there are no major structural concerns at this time.

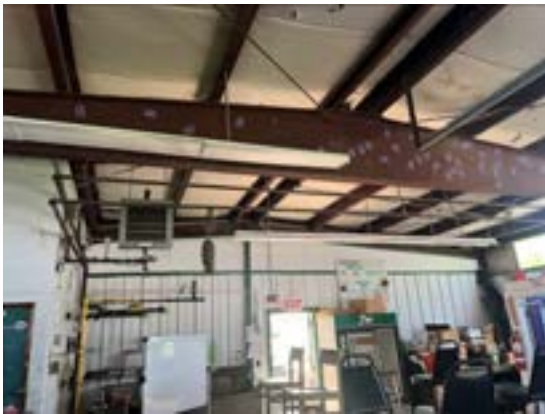
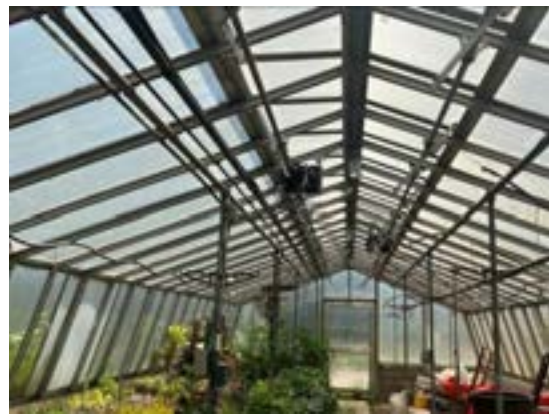
Typical Framing of the Horticulture Bldg. Roof and Greenhouse

The Horticulture facility has significant deficiencies, including crumbling foundations, inoperable/unsecured doors and windows, hazed over transparency panels and inoperable venting, and inadequate HVAC and ADA accessibility. The facility does not have bathrooms.

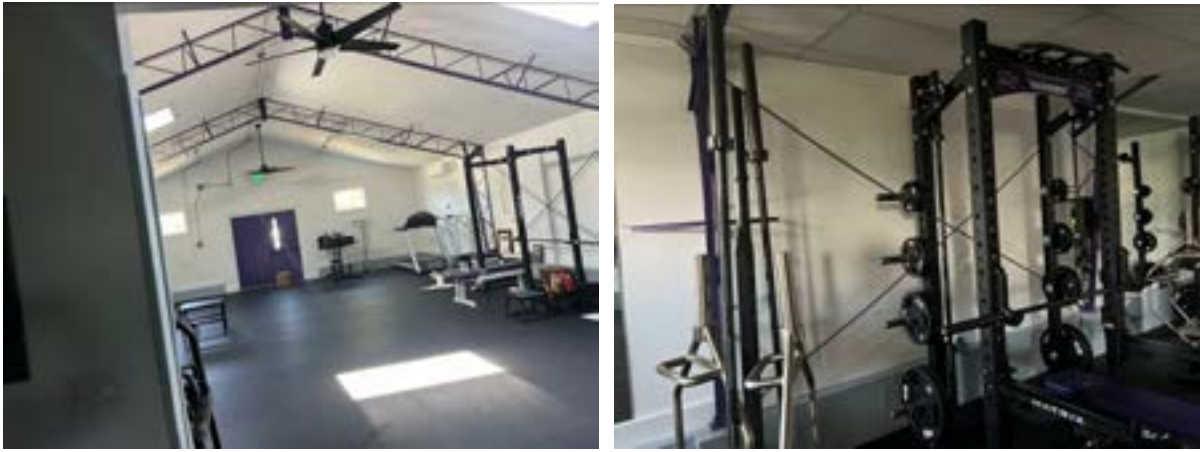
Typical Roof Framing of the Weightlifting Bldg.

The weight room is separate from the main building and has inadequate HVAC and ADA accessibility. The ACT ceiling and rubber flooring appear to be in decent condition. Having the small weight room away from the school is not conducive for PE class use or helpful for the athletic program.

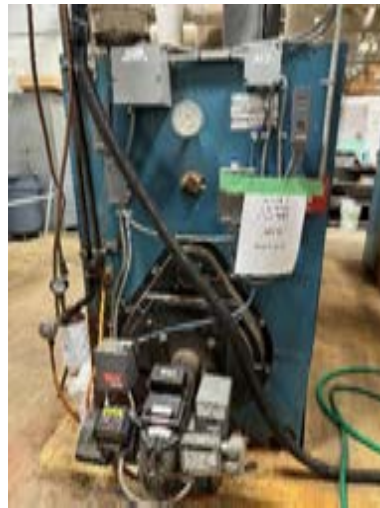
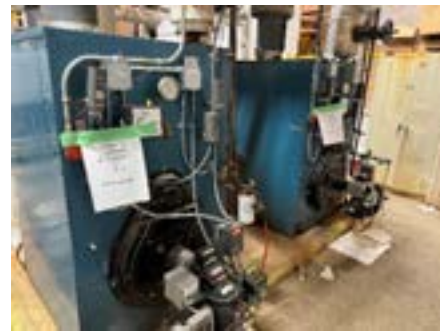
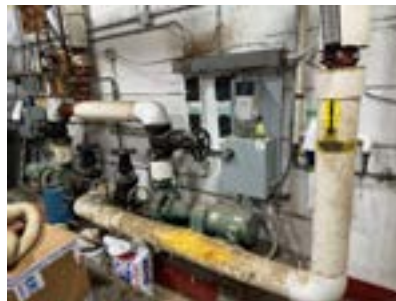
Boiler Plant #1 - 1969

- Boiler Plant #1 – Original 1959 Building
 - Heating is provided with (4) oil-fired hot water boilers that are original to the building. Boilers are 6 section, cast iron, standard efficiency Burnham FF-506 with Carlin 702CRD oil fired burners with 8.3 gallons per hour (GPH) capacity. These boilers are original to the building and have been maintained. The boilers are over 60 years old and in good condition for their age, but they are past their expected life span. Each boiler has an output capacity of 825 MBH for a total boiler plant capacity of 3,300 MBH.

- #2 fuel oil is stored in a 10,000 gallon underground storage tank. Condition of the tank could not be verified during the site visit. The duplex fuel oil pumps are located indoors but in a separate room from the boiler room.
- Hot water is distributed by two sets of two pumps with a primary/standby configuration for a total of four pumps. The pumps have been replaced and are in good condition. Age of the pumps is not known. Variable frequency drives (VFD) have been installed but are in Hand mode and do not modulate.
- Combustion air for the boilers is via roof mounted intake hood which is not compliant with current code.
- The insulated boiler flues tie together and turn up in a chimney that terminates on the roof.

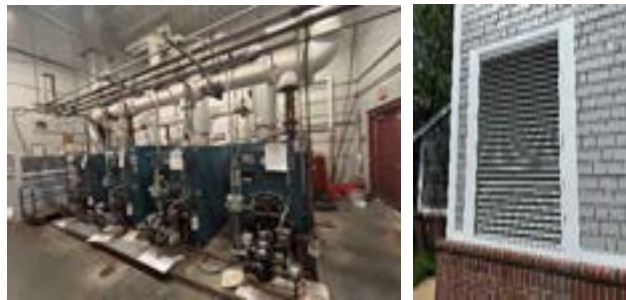
- Boiler Plant #2 - 1992 Addition
 - Heating is provided with (4) oil-fired hot water boilers that are original to the building. Boilers are 9 section, cast iron, standard efficiency Burnham FF-509 with Carlin 801CRD oil fired burners with 12.6 gallons per hour (GPH) capacity. These boilers are original to the building and have been maintained. The boilers are over 30 years old and in good

condition for their age, but are at their expected life span. Each boiler has an output capacity of 1,250 MBH for a total boiler plant capacity of 5,000 MBH.

- #2 fuel oil is stored in a 10,000 gallon underground storage tank. Condition of the tank could not be verified during the site visit. The duplex fuel oil pumps are located indoors but in a separate room from the boiler room.
- Hot water is distributed by two sets of two pumps with a primary/standby configuration for a total of four pumps. One set of pumps serves the Performing Arts Center (PAC), and the other set of pumps serves the remainder of the 1992 and 1994 additions. The pumps are original and in good condition. Variable frequency drives (VFD) have been installed but are in Hand mode and do not modulate.
- Combustion air for the boilers is via a wall mounted louver with ductwork that turns down to 12" above the floor.
- The double wall boiler flues tie together, turn up and terminate on the roof.

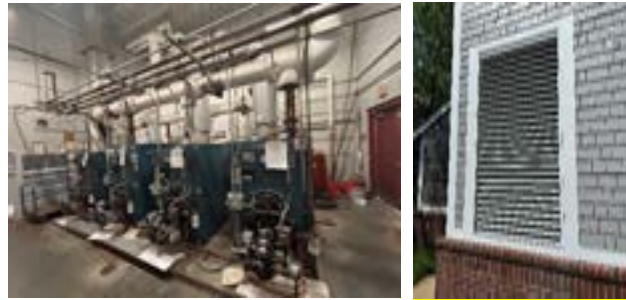
Boiler Plant #2 - 1992

condition for their age, but are at their expected life span. Each boiler has an output capacity of 1,250 MBH for a total boiler plant capacity of 5,000 MBH.

- #2 fuel oil is stored in a 10,000 gallon underground storage tank. Condition of the tank could not be verified during the site visit. The duplex fuel oil pumps are located indoors but in a separate room from the boiler room.
- Hot water is distributed by two sets of two pumps with a primary/standby configuration for a total of four pumps. One set of pumps serves the Performing Arts Center (PAC), and the other set of pumps serves the remainder of the 1992 and 1994 additions. The pumps are original and in good condition. Variable frequency drives (VFD) have been installed but are in Hand mode and do not modulate.
- Combustion air for the boilers is via a wall mounted louver with ductwork that turns down to 12" above the floor.
- The double wall boiler flues tie together, turn up and terminate on the roof.

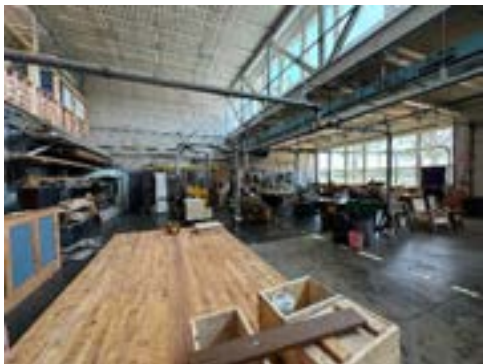
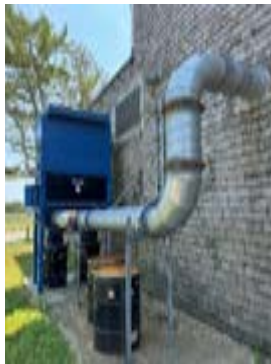
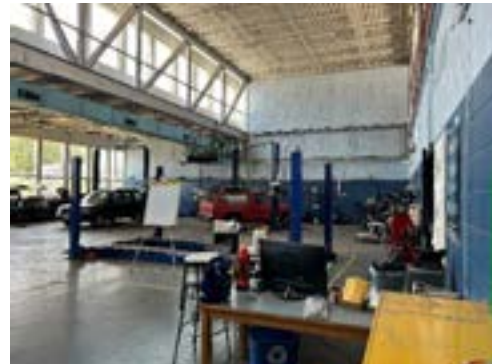
- Each space is served by an AHU for heating and ventilation and also exhaust systems. The AHU are ceiling mounted and exposed in the space with overhead duct distribution with supply grilles. These operate continuously with no nighttime or weekend setback. These spaces also utilize exterior overhead doors for natural ventilation during moderate outdoor conditions. The Wood Shop includes a dust collection system that is new and appears code compliant. The Auto Shop contains a vehicle exhaust collection system that is routed in the floor slab. This system old and past its expected service life.
- Each space also has a ceiling mounted hot water unit heater to temper the large exterior glass walls.

Wood Shop AHU

Wood Shop Dust Collection Auto Shop AHU

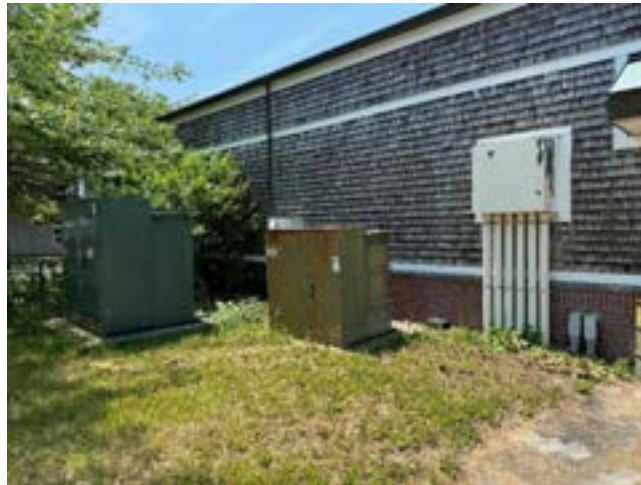
Exterior Utility Transformers

- The main electrical service and power systems are aged and should be replaced for the potential inclusion of building-wide electrified heating, ventilating and air conditioning systems. The existing electrical rooms may not be physically large enough for the newer switchboards. Additionally, the transformers may not be providing (2) 2000A services. This should be verified by the utility.
- There are panelboards located throughout the facility, including the Shop and Kitchen spaces. Panelboards are in fair to poor condition, with some being original to the building, and some from additions in the 90's. There are some small dry-type transformers used to step down to 208Y/120V.
- There is a wind electric interconnection system for a single wind turbine that has not been maintained and is not operational.

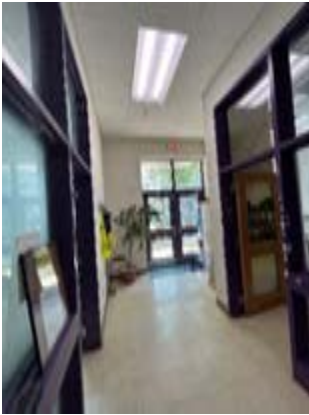
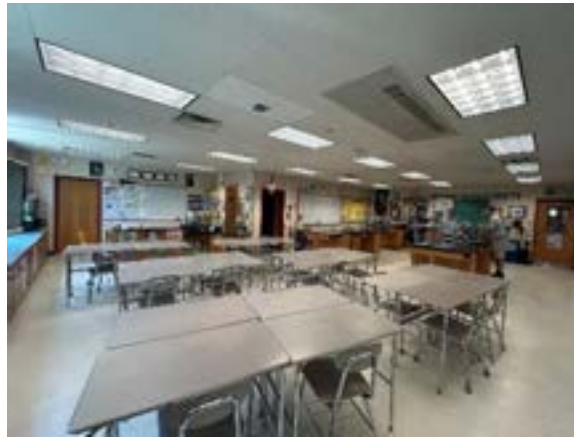
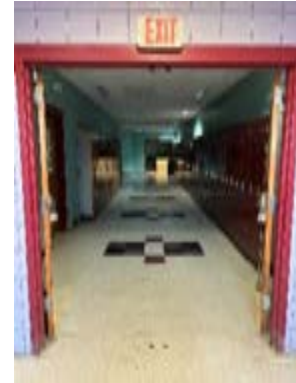
- Lighting is primarily T8 fixtures.
- Lighting does not meet latest energy code requirements requiring local control of fixtures. Not all required spaces have lighting controls beyond switching. Emergency lighting controls shall be reviewed.

- Most classrooms and restrooms have local wall switches with occupancy sensors.
- Exit signs are located throughout the building. Coverage will need to be reviewed. All exit signs were not functional.
- A mixture of lay-in fixtures, indirect pendants, surface mounted fixtures, downlights, and track lighting were observed.
- Site lighting is primarily building mounted. Pole-mounted fixtures were observed in the parking lots. Exterior lighting appears to be newer LED fixtures.

Typical Lighting Systems

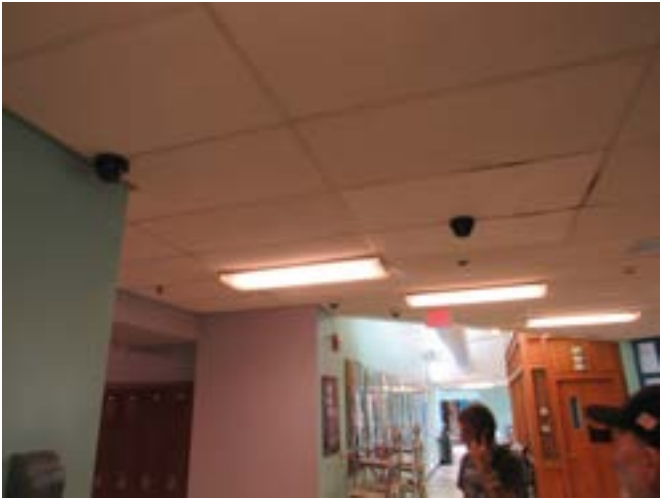
MULTIPLE CAMERAS AT A SINGLE APEX INTERNALLY

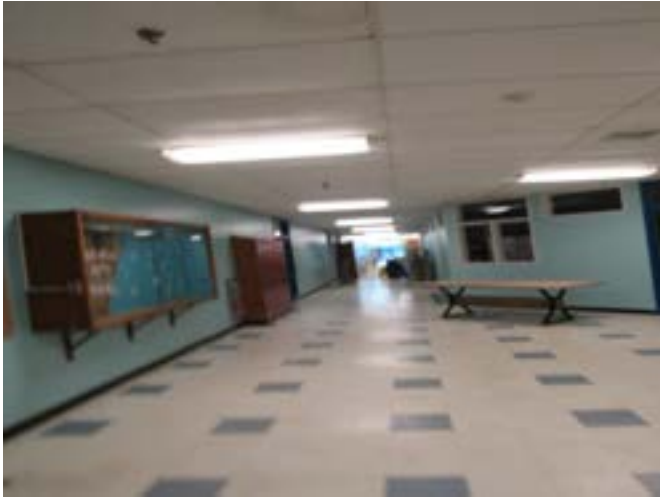
NO CAMERAS IN LENGTHY HALLWAY.

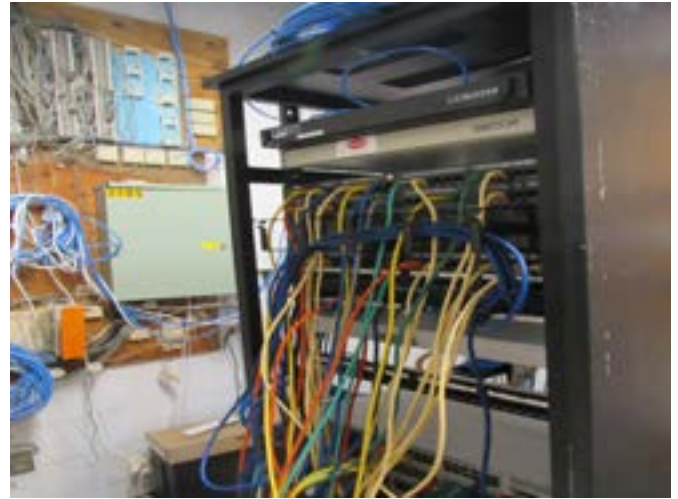
NO COHESIVE COLOR CODING TO PATCH CABLES FOR SYSTEMS.

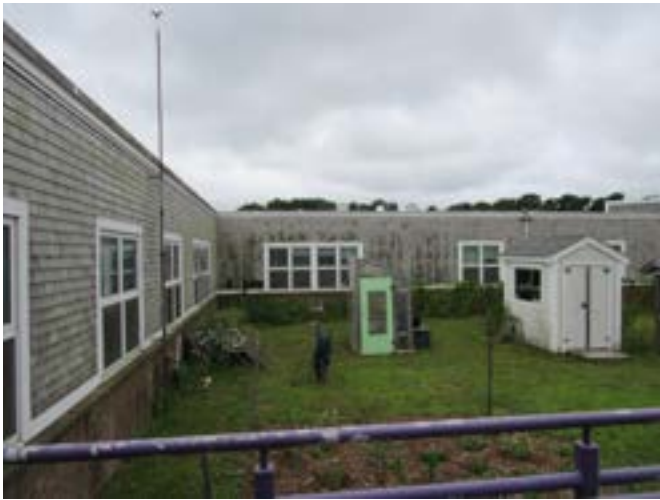
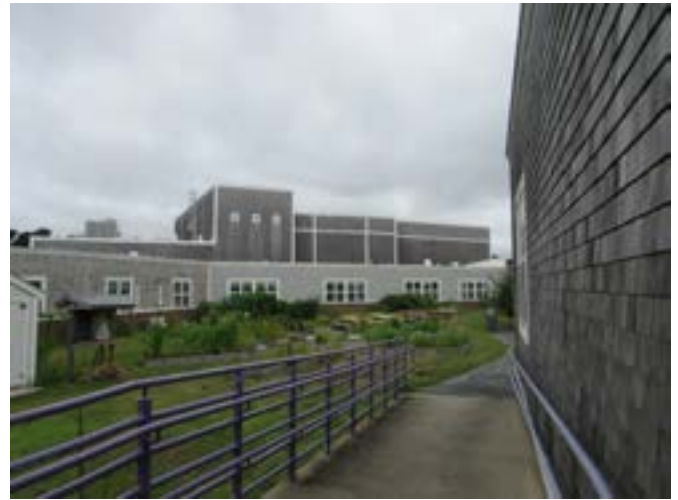
BEAUTIFUL GARDENS, BUT UNSECURE SCHOOL ENTRANCES FROM GARDENS AND COURTYARD.

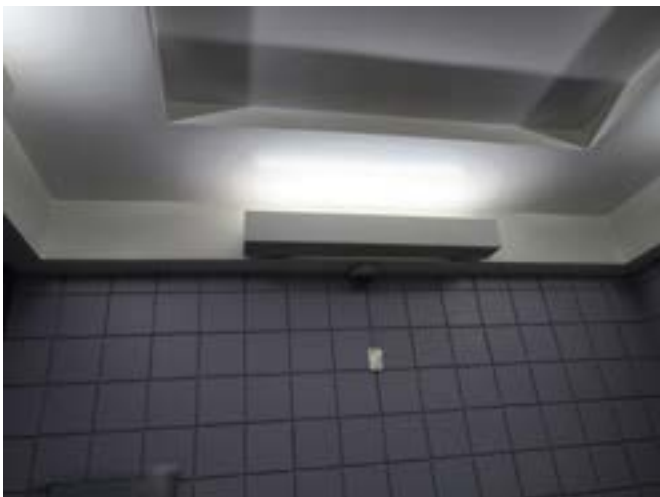
INTERIOR CAMERA MOUNTING INCONSISTENCY.

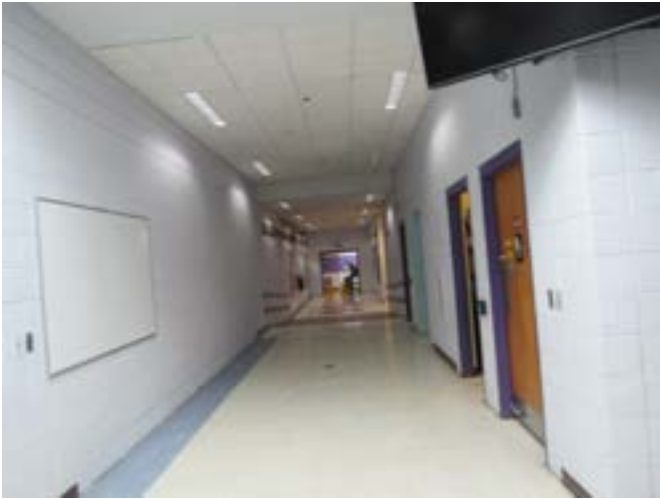
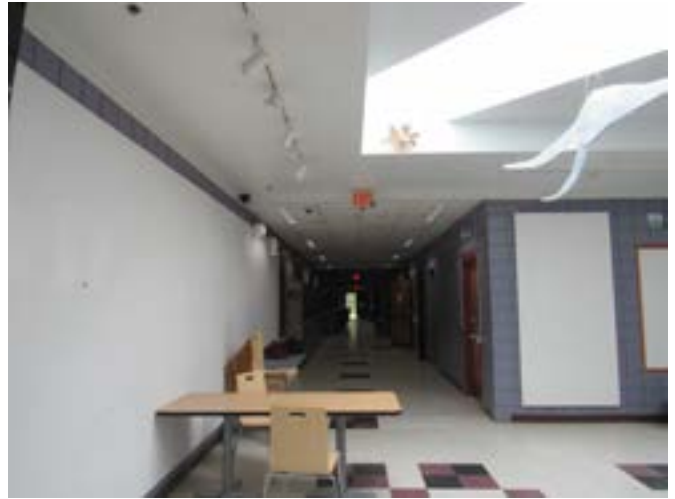
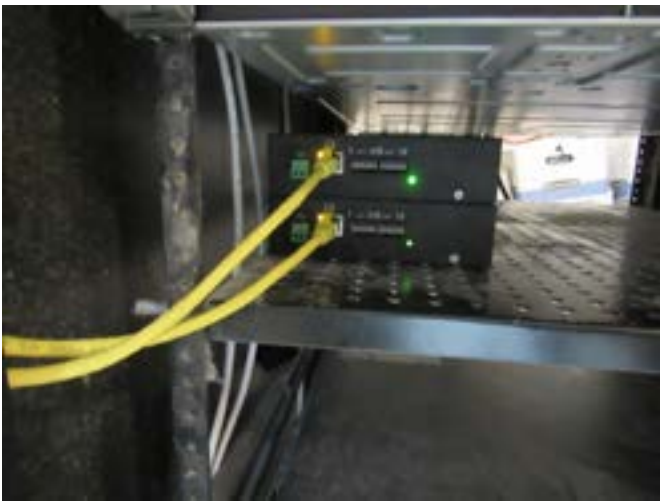
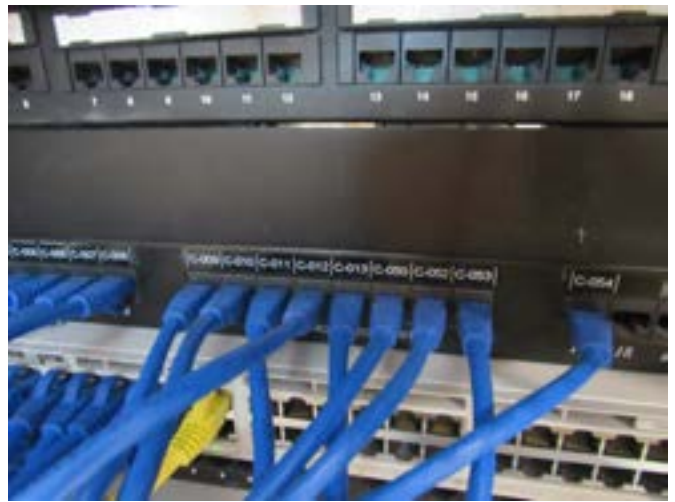
CAMERA PATCH PANEL WITH SOME CONSISTENCY.

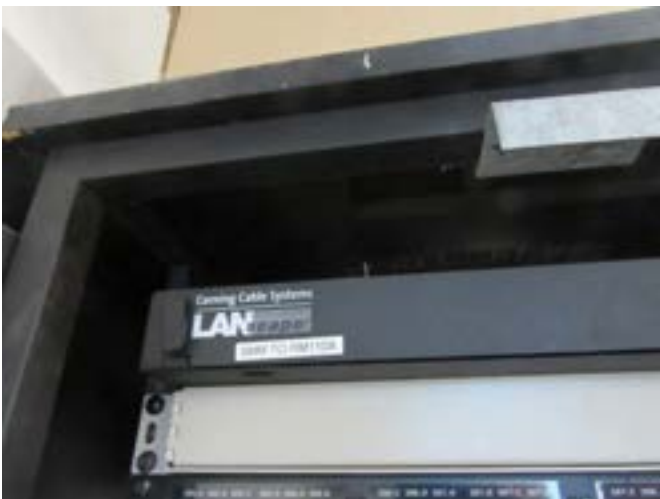
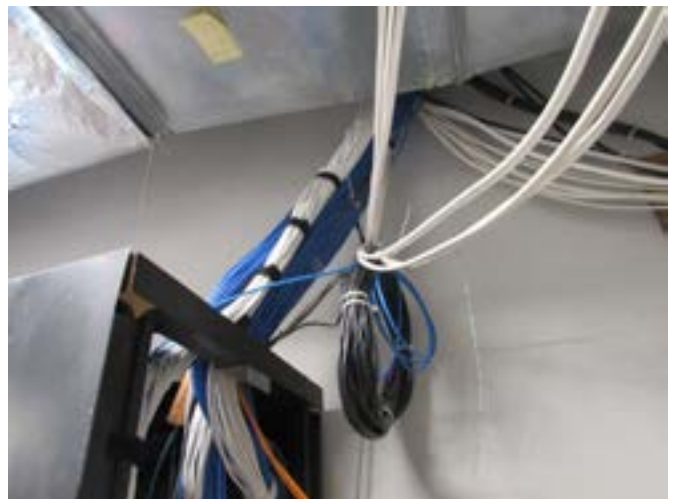
MORE CLEAN CAMERA WIRE INSTALLATION

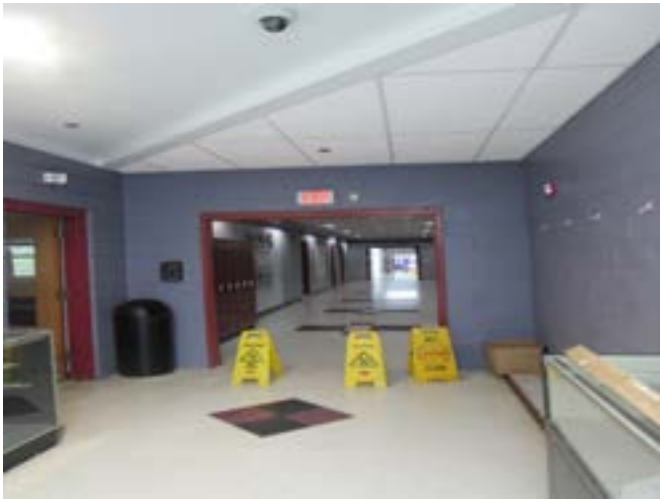
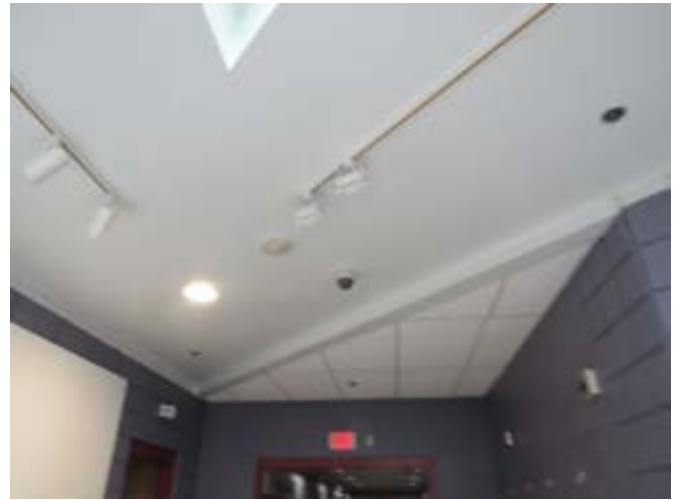
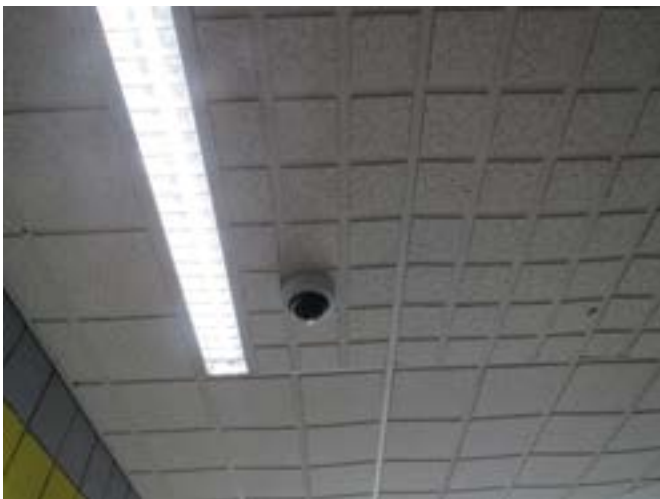
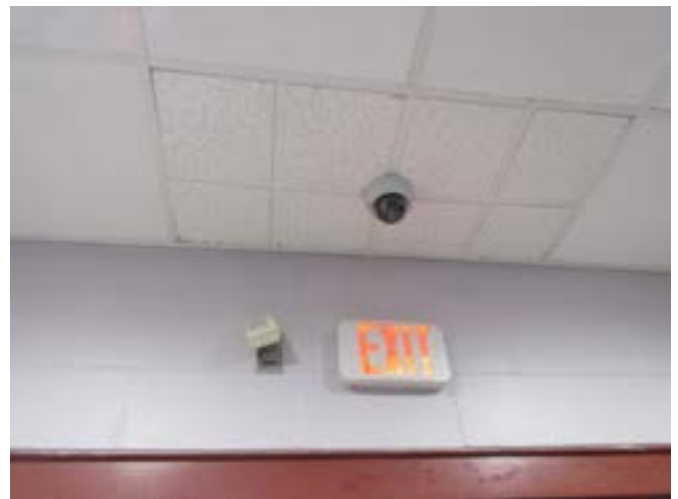
OLD SENSOR FOR LIGHTING NOT INTRUSION. CAMERA.

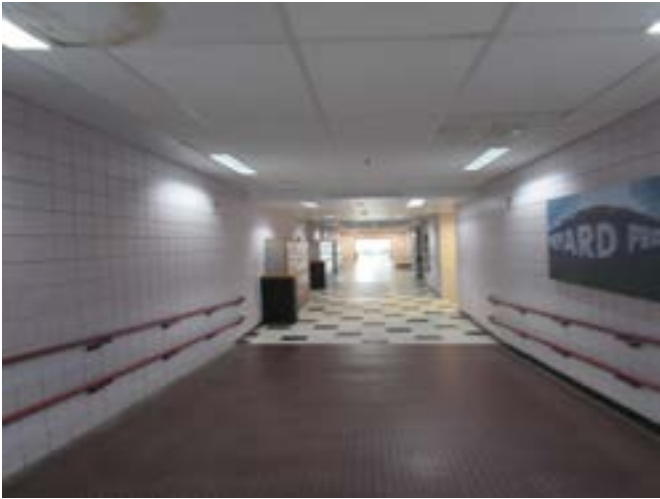
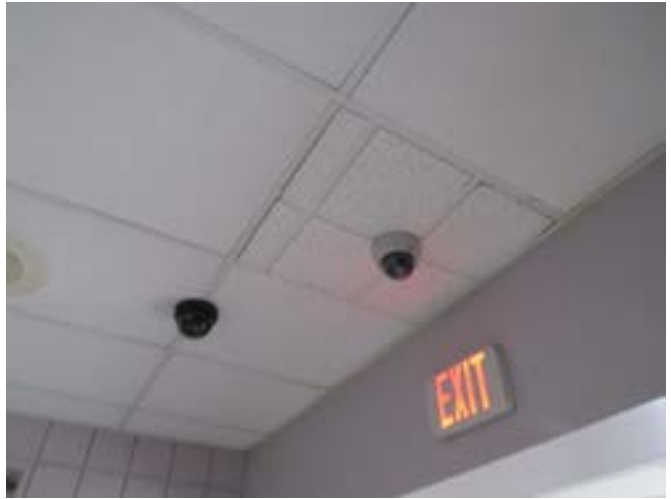
LIMITED UTILIZATION OF MULTI-SENSOR CAMERAS.

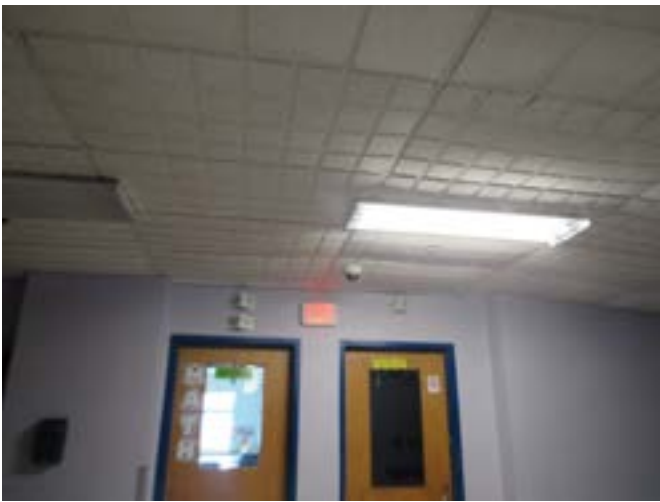
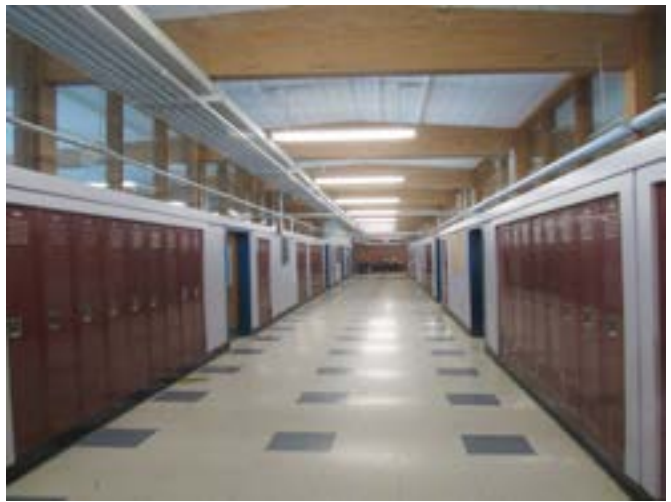
NO PERIMETER DOOR MONITORING.

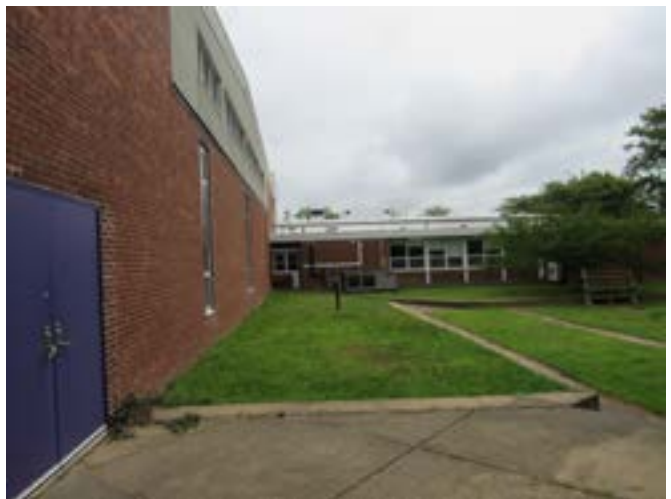
EXTERIOR COURTYARD WITH UNSECURE DOORS.

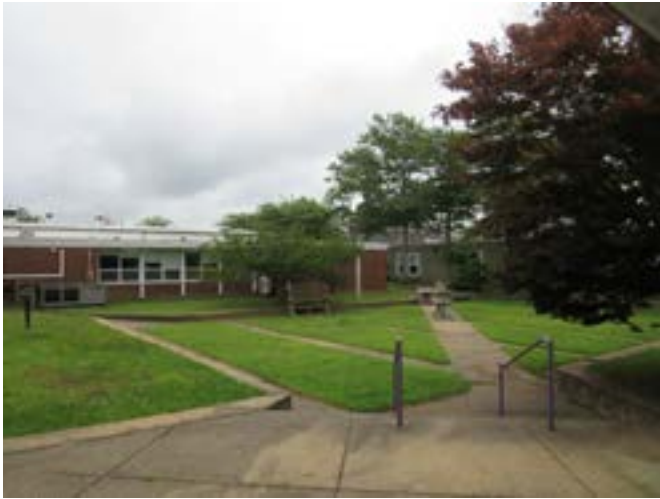
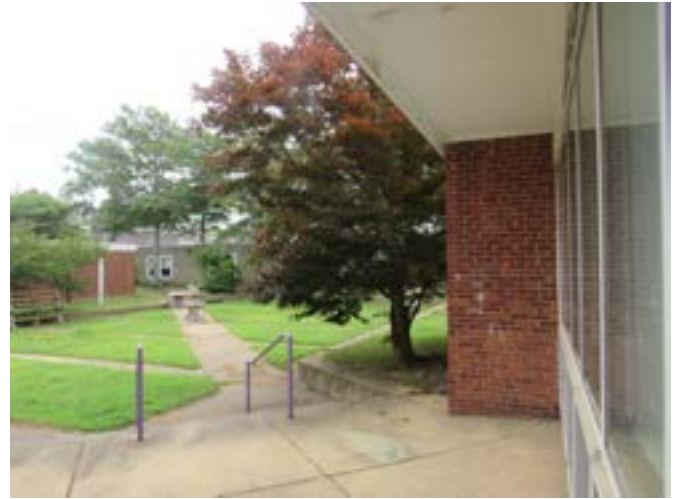
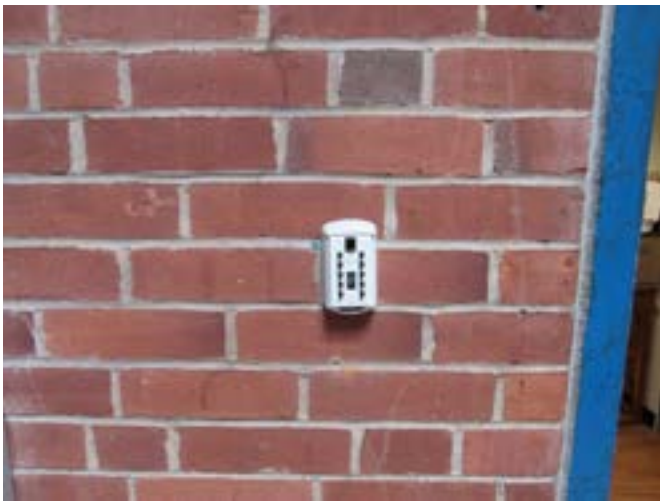
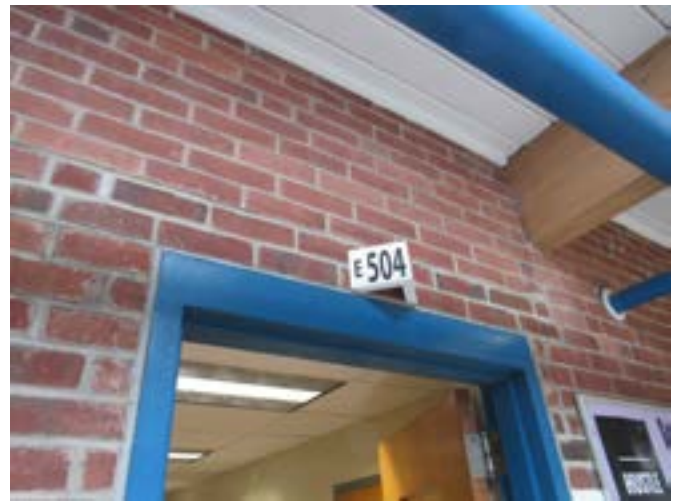
CYPHER LOCK BOX WITH INTERNAL KEY FOR DOOR.

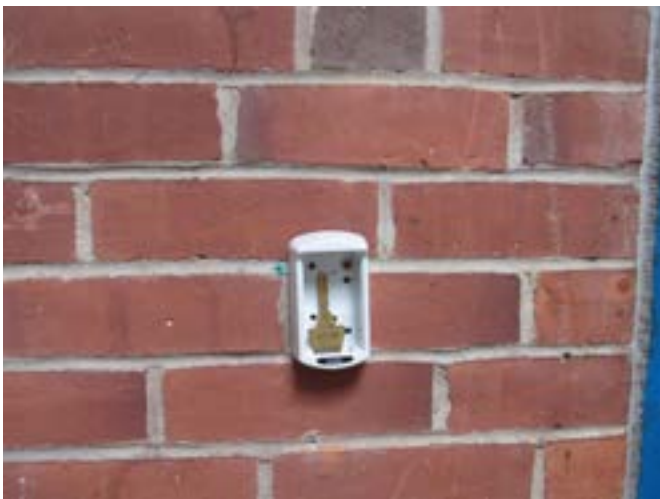
VIDEO AT ENTRANCE. SECURE VESTIBULE CONFIGURATION.

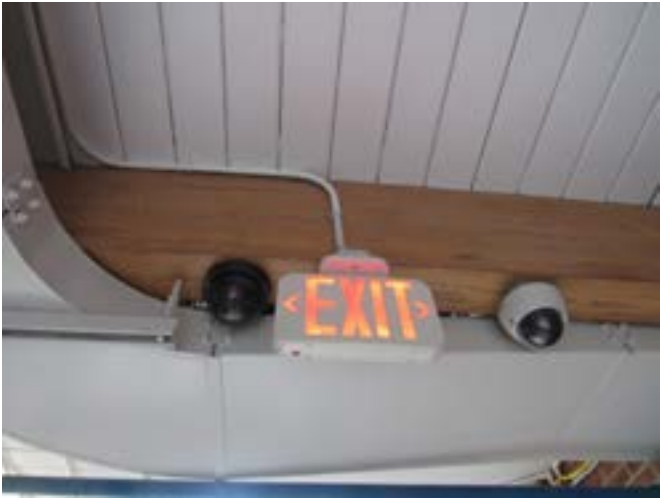
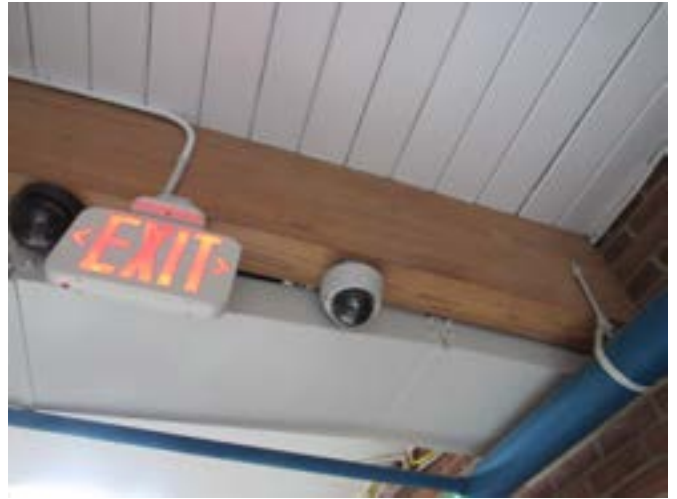
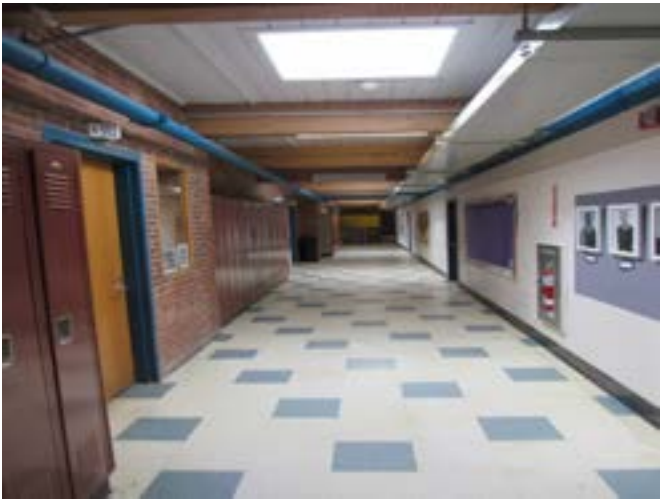
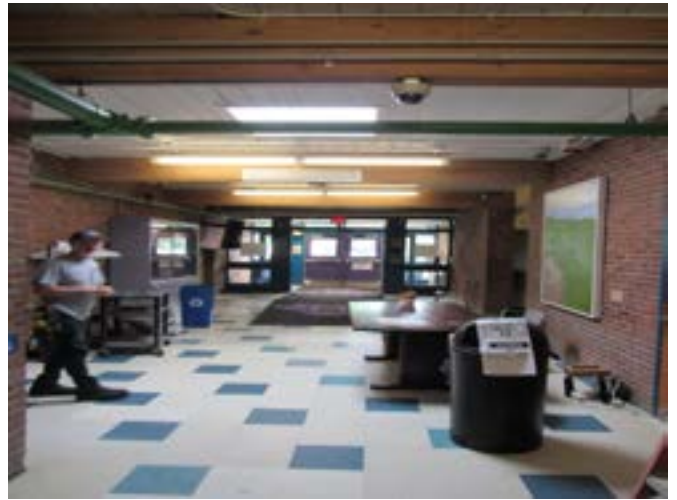
OLD CABLE TRAY TOP RIGHT.

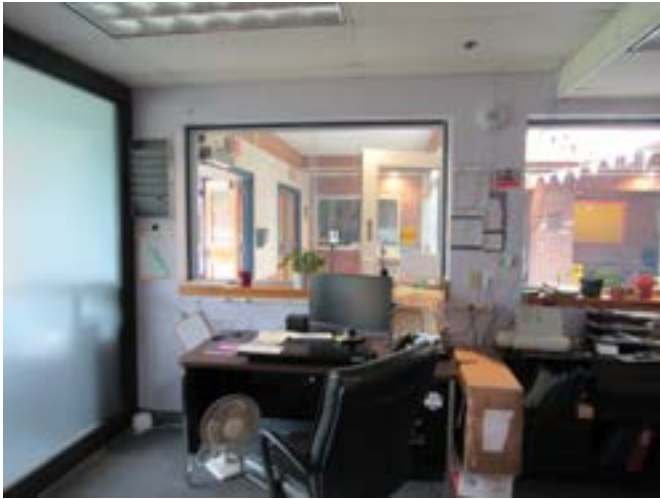
NO INTERIOR PASS THRU OR COMMUNICATION WINDOW INTO ADMIN SUITE.

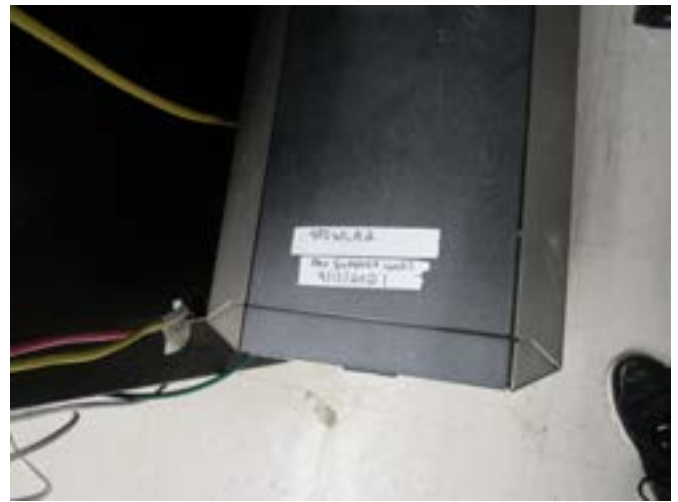
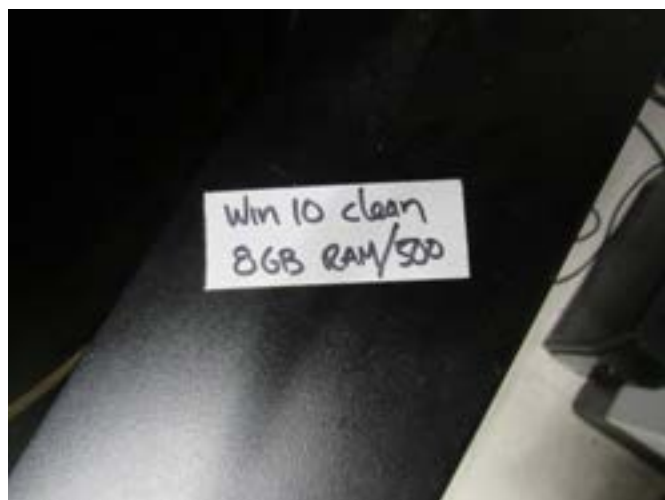
WINDOWS 10 OS REQUESTED BY VENDOR PROVIDED BY OWNER.

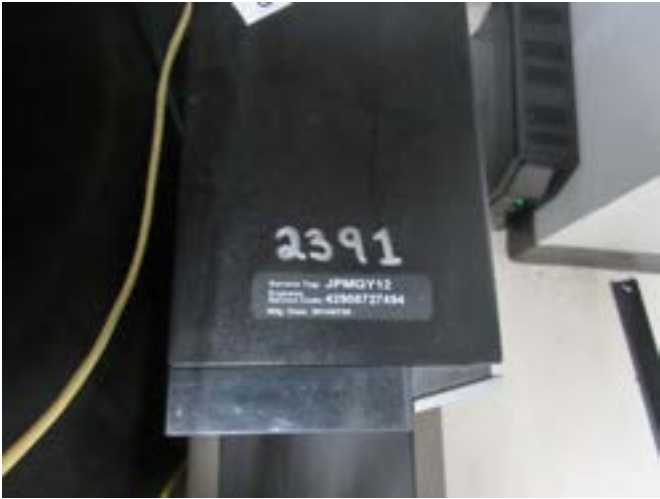
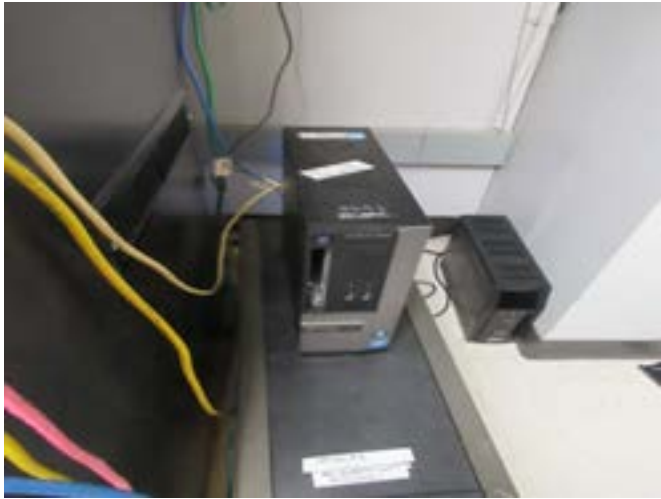
2014 SERVER

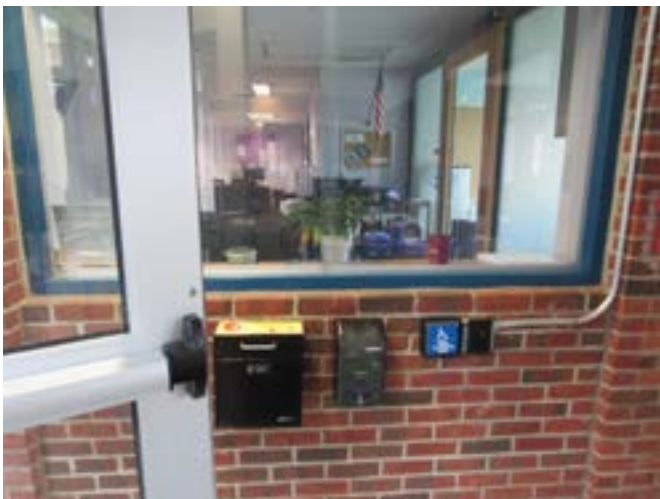
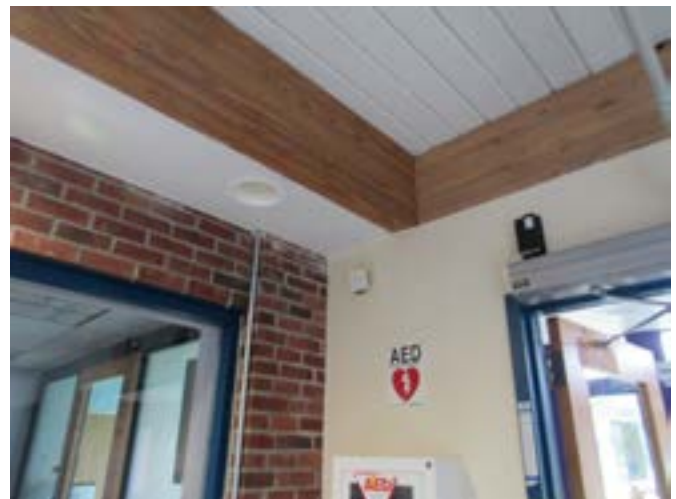
SINGLE INTERIOR CARD READER. DO NOT KNOW WHAT IT IS CONFIGURED TO.

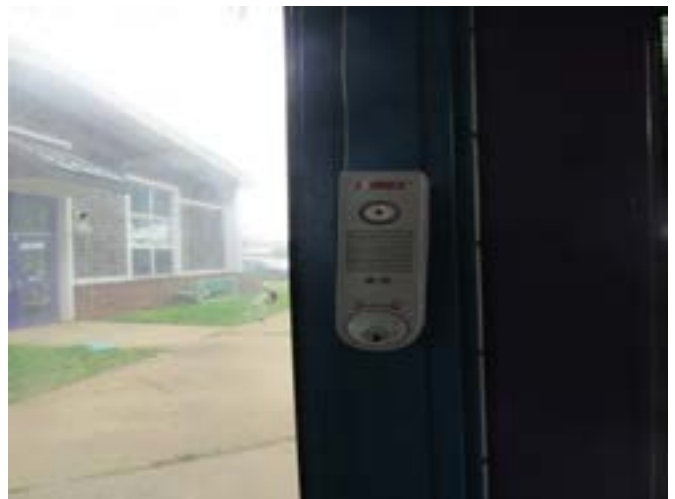
DETEX DEVICE FOR MONITORING WITH SOUNDER AND KEYSWITCH.

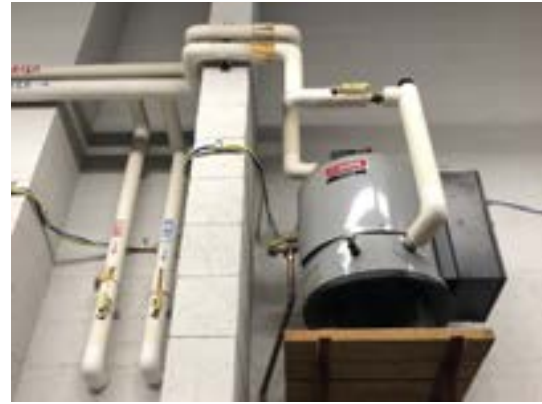
Electric Water Heater

There is a wall-mounted high-kw electric water heater located in the custodial/maintenance staff area.

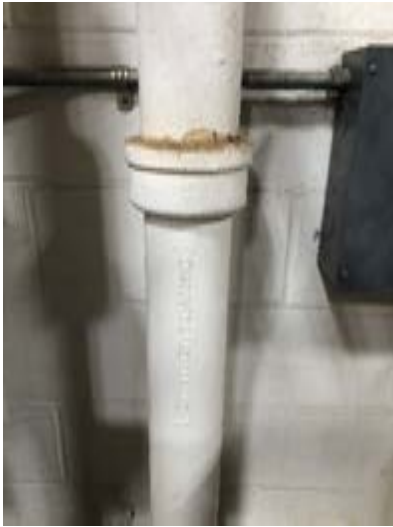
Hub & Spigot Cast Iron Vent Pipe

What could be seen of the existing sanitary drain, waste and vent system appears to be a combination of drainage pattern copper, cast iron, and galvanized steel. The majority of the piping is hub and spigot cast iron with either gasketed or leaded and caulked joints, with some no-hub cast iron pipe with rubber couplings and stainless steel bands with shields. Copper drainage piping is limited primarily to fixture connections. Galvanized steel appeared to be limited to vents only. Visible piping appeared to be in good condition, with little evidence of active leaks.

Although the storm and sanitary drainage system piping appears to be in good condition, a minimal amount was visible during our visit, therefore extensive investigation should be conducted prior to reuse or

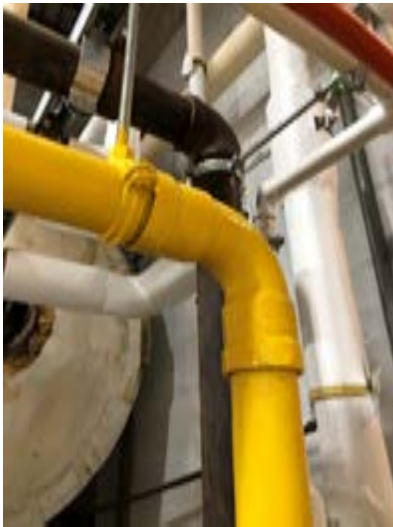
Pressed Gas Pipe Fitting

The building is equipped with multiple exterior LP tanks located sporadically around the building. The tanks serve the kitchen, culinary arts, domestic water heaters, and science classrooms. The kitchens and science classrooms appear to be equipped with emergency gas shutoffs, although the kitchen system may not be interlocked with the kitchen exhaust and does not have a manual shutoff. Gas piping is steel with pressed or threaded fittings, and appears to be in good condition.

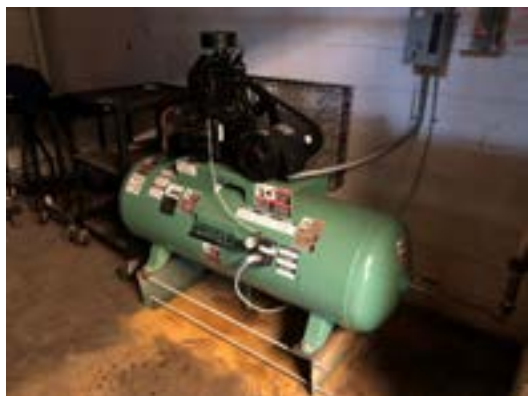
Air Compressor

A Speedaire 1WD82A tank mounted air compressor provides compressed air to the shops. Compressed air piping is threaded schedule 40 steel or copper tube and appears to be in good condition.

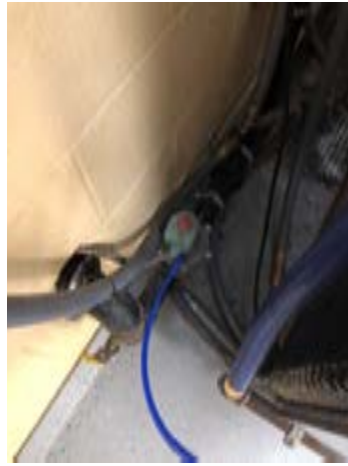
Kitchen Gas Solenoid Valve

- Kitchen gas supply may not be properly interlocked with the kitchen hoods.
- Domestic water piping insulation thickness may not meet current energy code requirements should be inspected and replaced where it has been damaged or does not meet current energy code requirements.

All deficiencies noted above should be addressed.

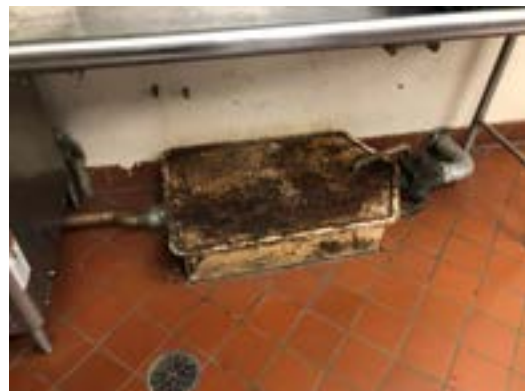
Low Profile Grease Interceptor

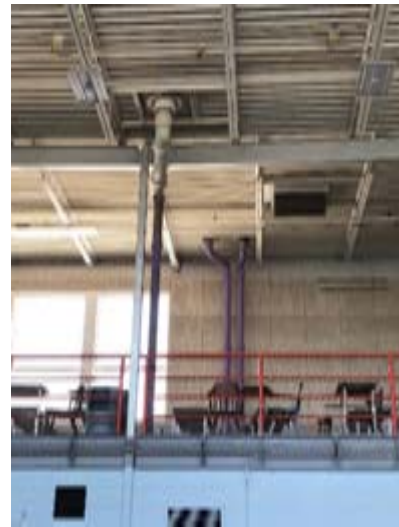
Roof Drain and Oil Separator Vents

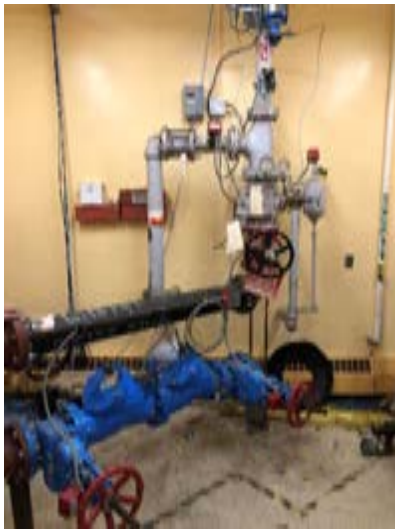
1959 Fire Service

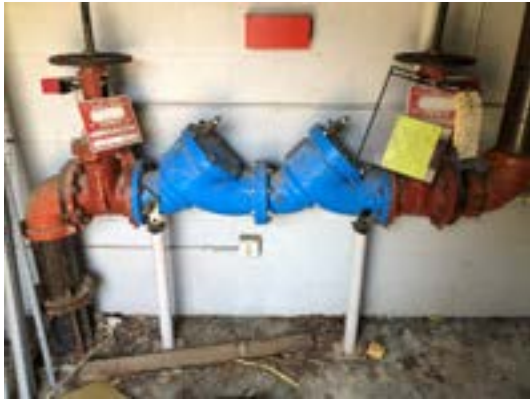
1990's Fire Service

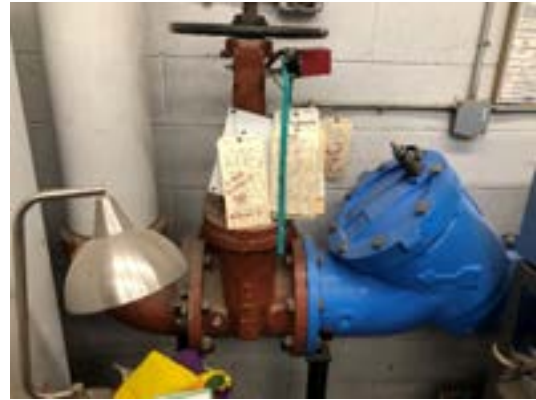
1990's Fire Service

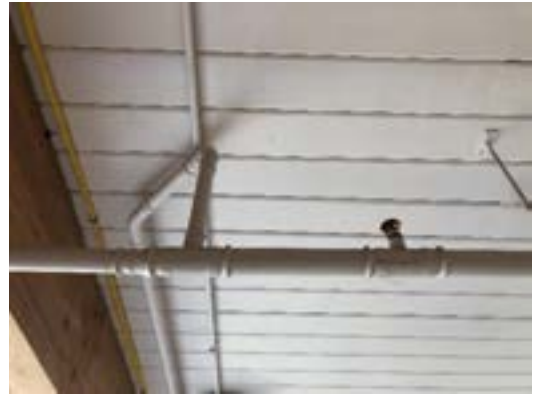
Press Fit Pipe Fittings

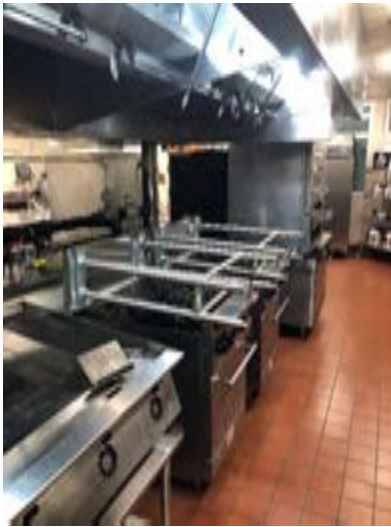
Culinary Arts Hood Suppression
